House On The Rock Inspections

Property Condition Report

123 Inspectors St, City, TN 23456
Inspection prepared for:
Real Estate Agent: -

Date of Inspection: 6/7/2021 Time: 12:00 PM
Age of Home: 2002 Size: 3615

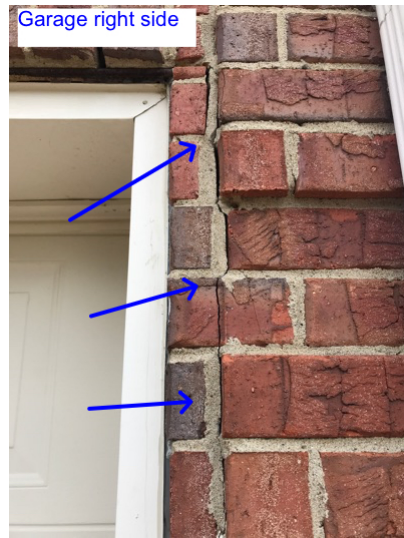
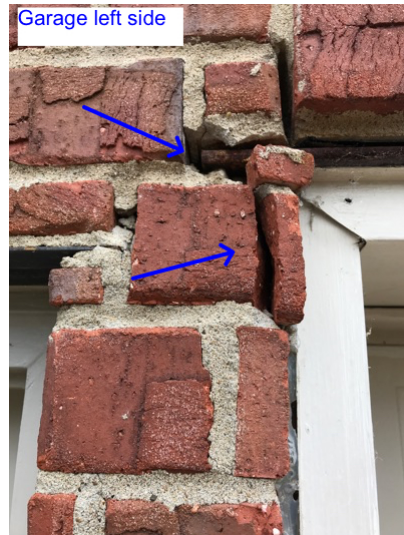
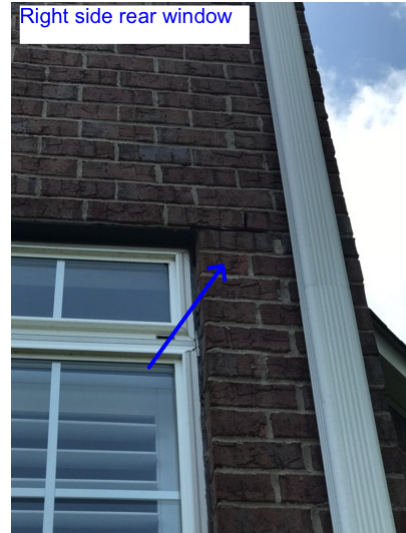
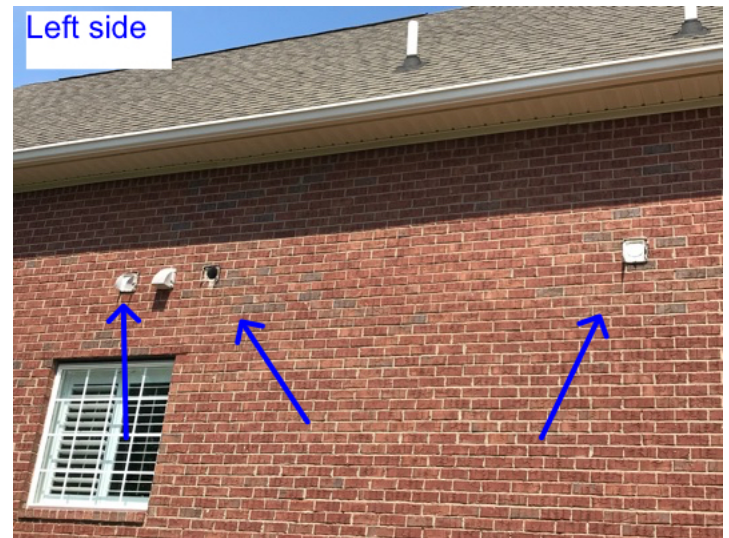
- The stone siding was in contact with the ground. A minimum of a 4" clearance is necessary between the ground and the stone siding on the home. Recommend making the needed adjustments to allow for the proper clearance.
- Missing brick mortar was noted around areas of the house. Recommend sealing the open gaps to prevent moisture entry and further deterioration.
- The Hardie siding was in contact with the roofing shingles. A minimum of a 2" clearance is necessary between the ground/roof and the siding on the home. Recommend making the needed adjustments to allow for the proper clearance per the manufacturer's installation requirements.
- Missing vent baffles were noted on the left side of the house. Recommend repair to prevent pest and moisture intrusion.

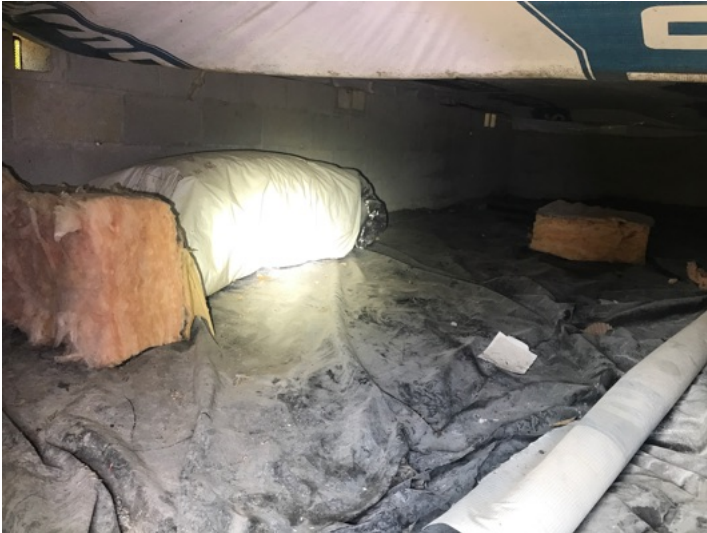
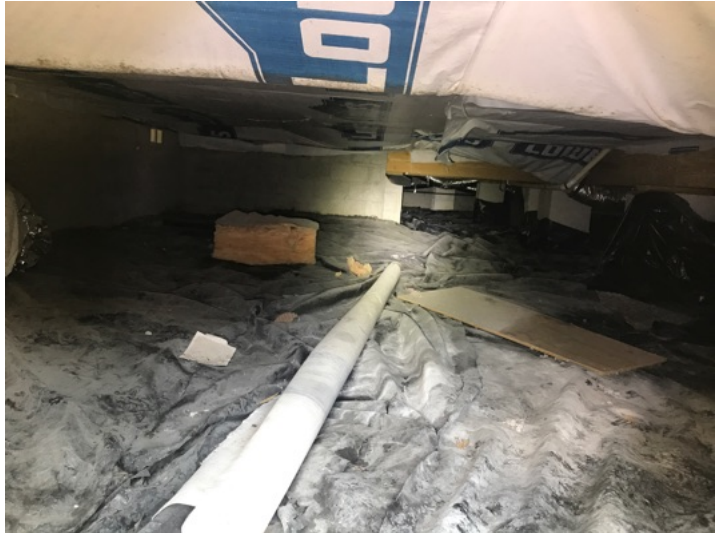
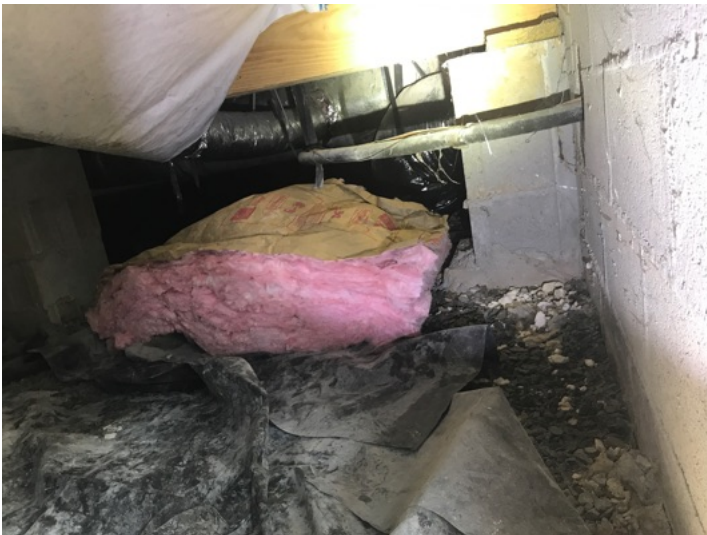
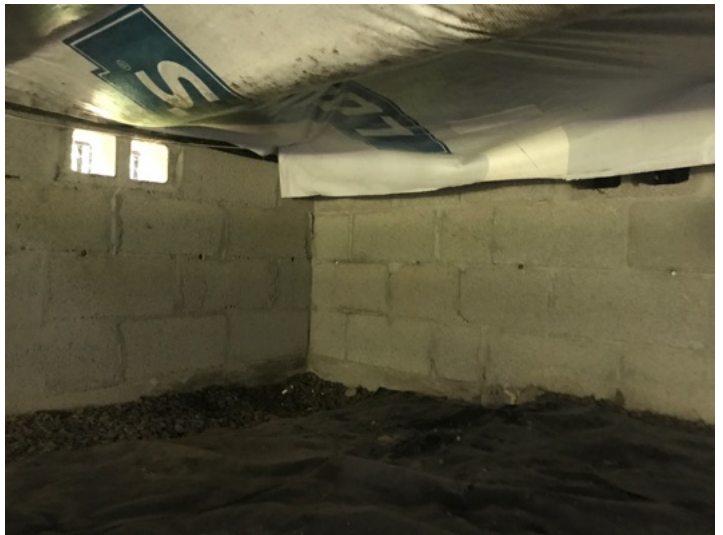
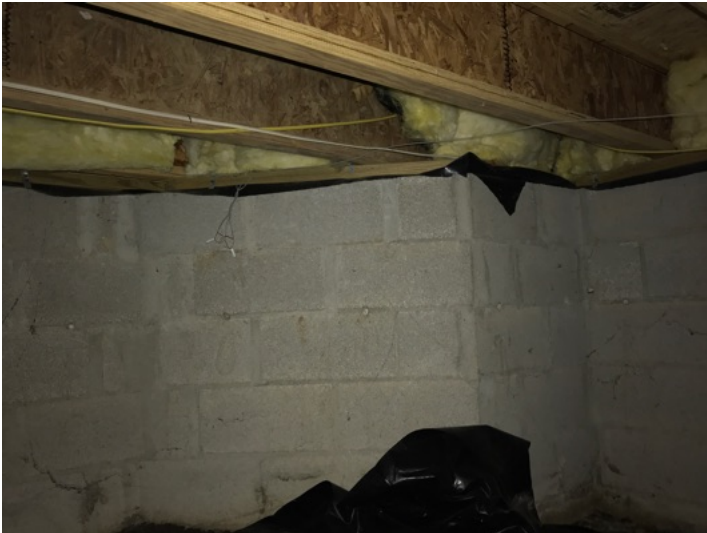
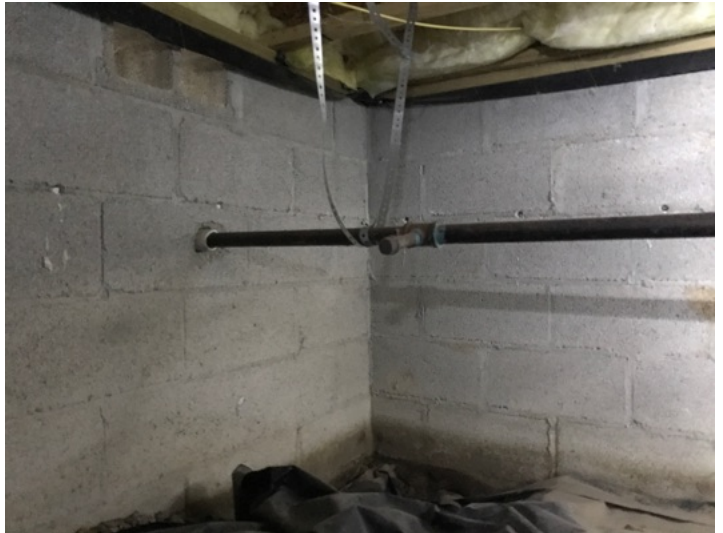
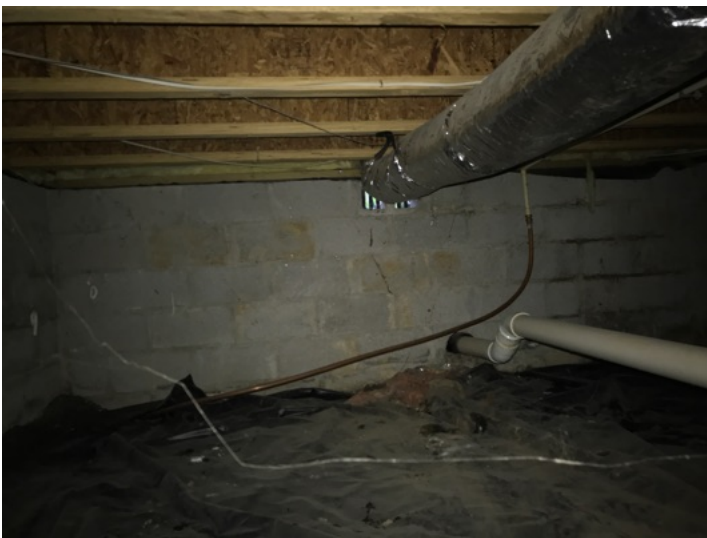
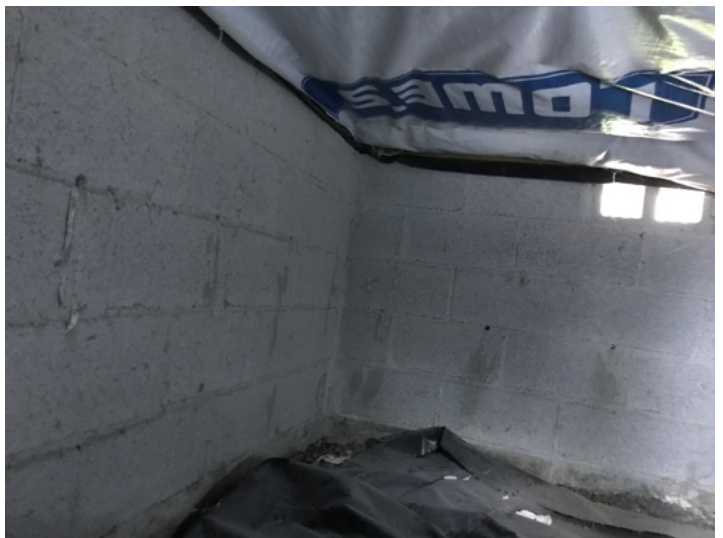
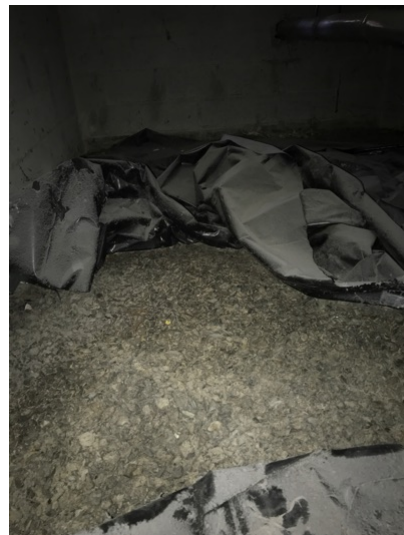
- The moisture barrier in place had shifted. Recommend having the barrier adjusted for proper coverage.
- Lint was noted in the crawlspace under the dryer vent. It appeared that the dryer vent had been damaged and repaired. Recommend removing all excess lint for optimal performance.

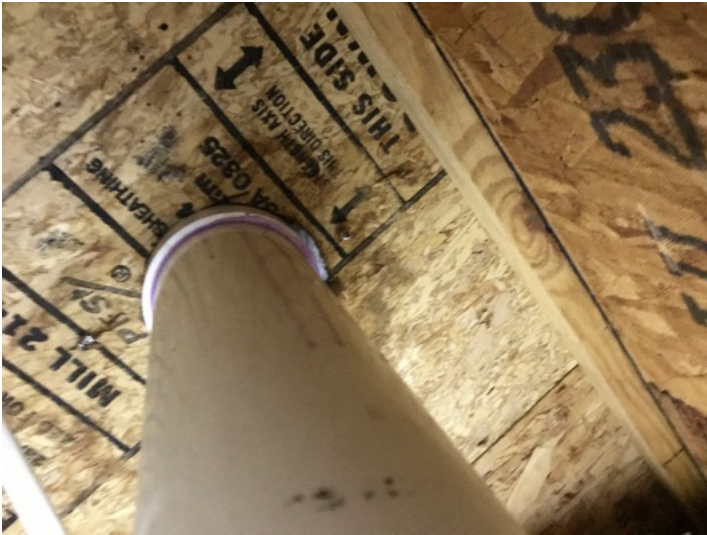
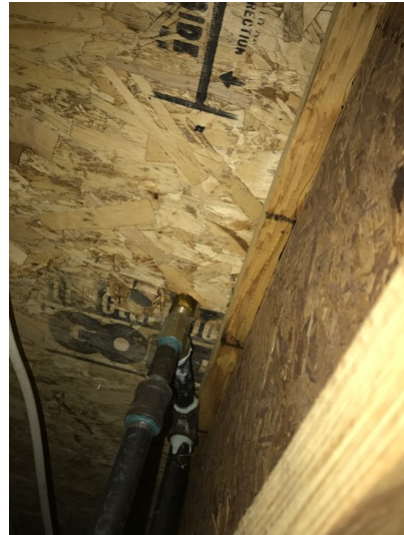
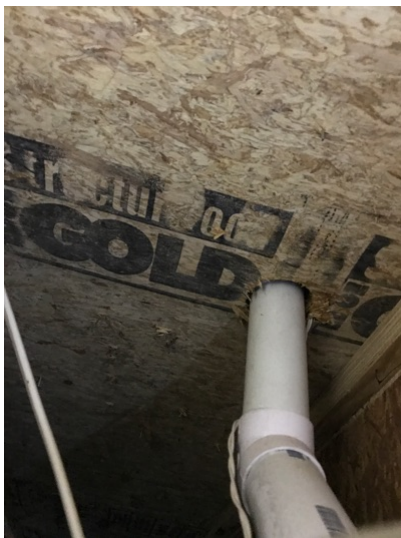
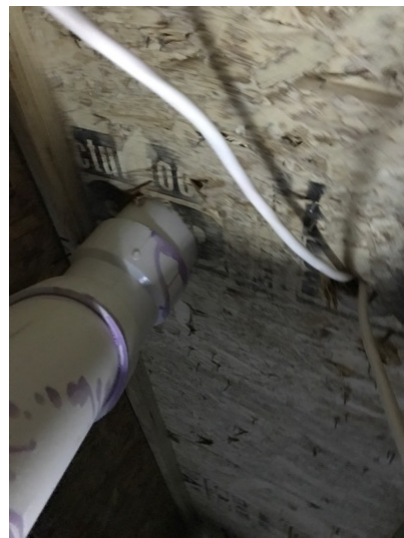
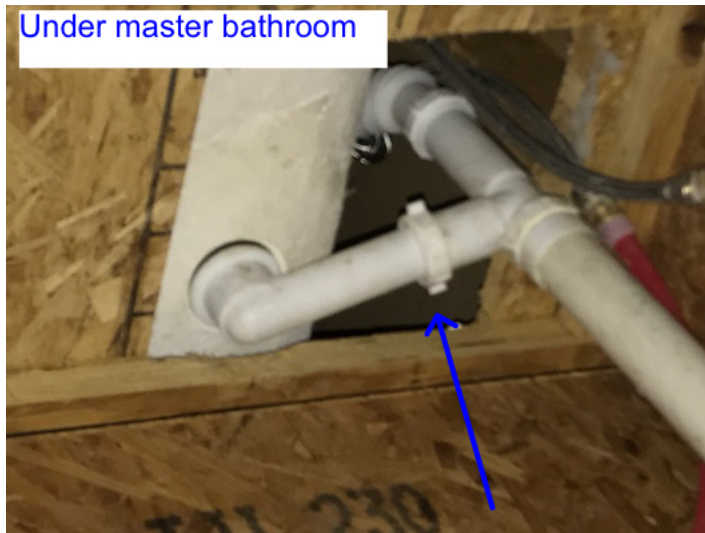
Under master bathroom

- Large open gaps were noted in the sub floor under the master bathroom. Recommend sealing those openings for optimal performance.

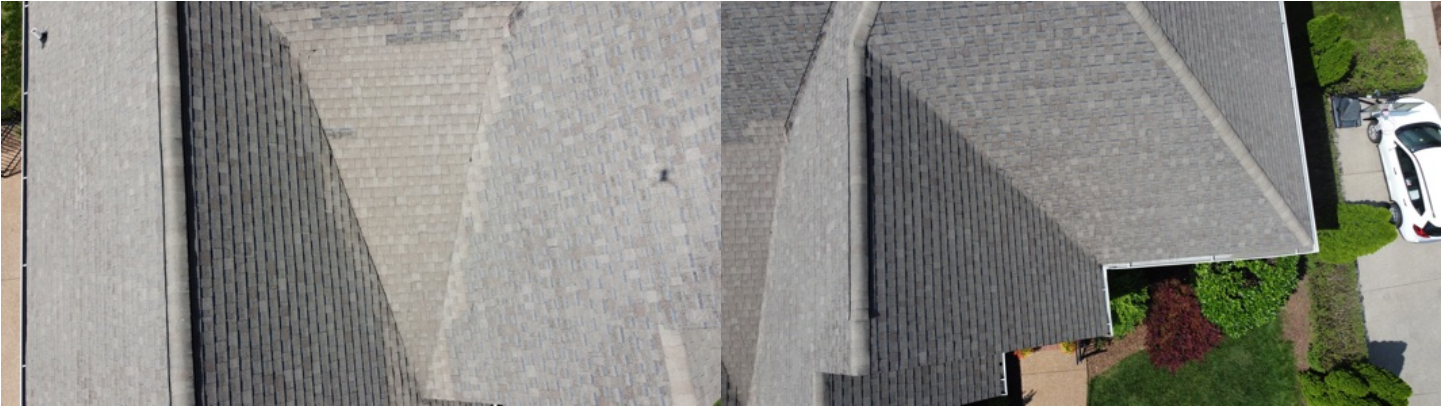
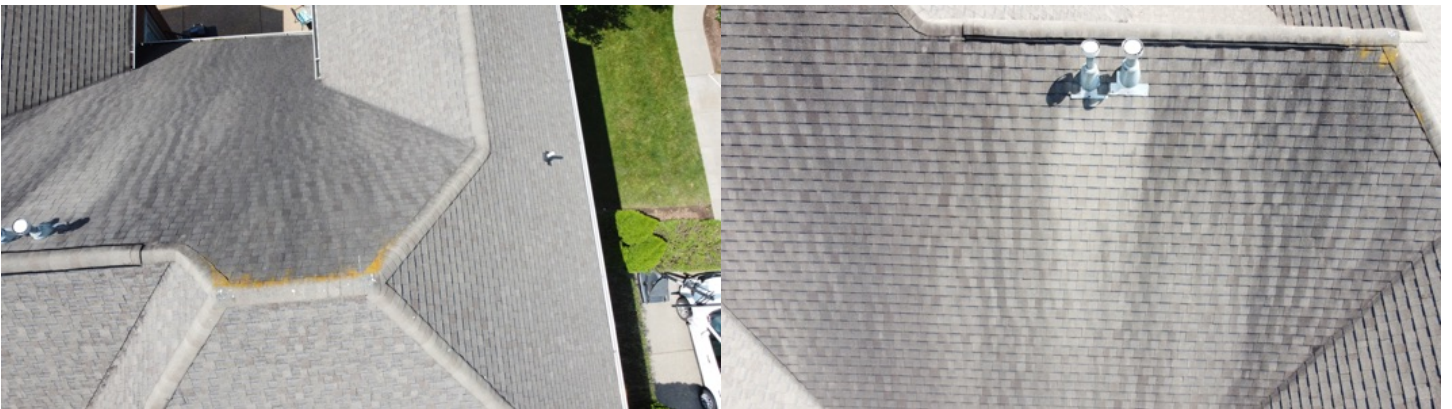
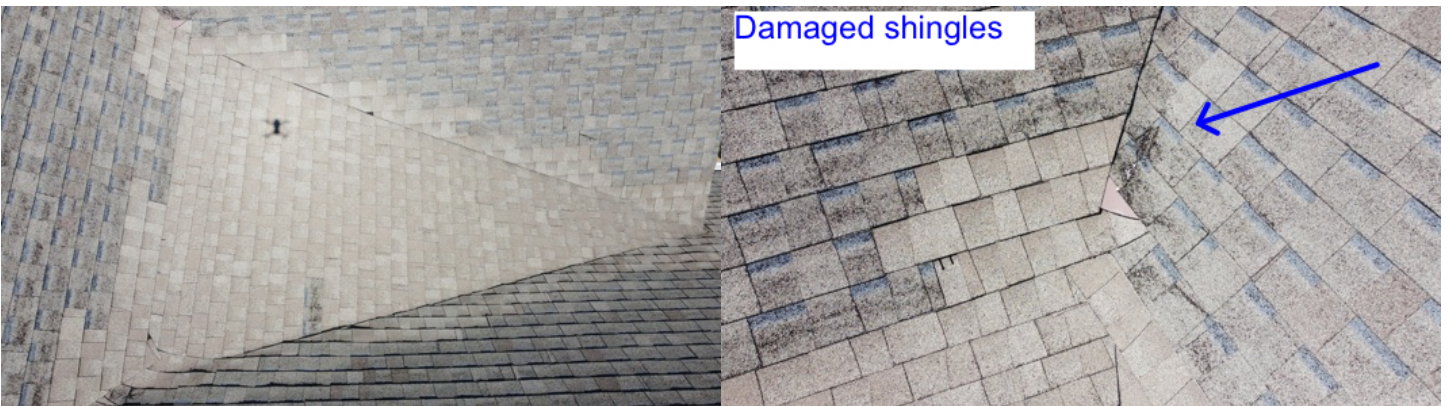
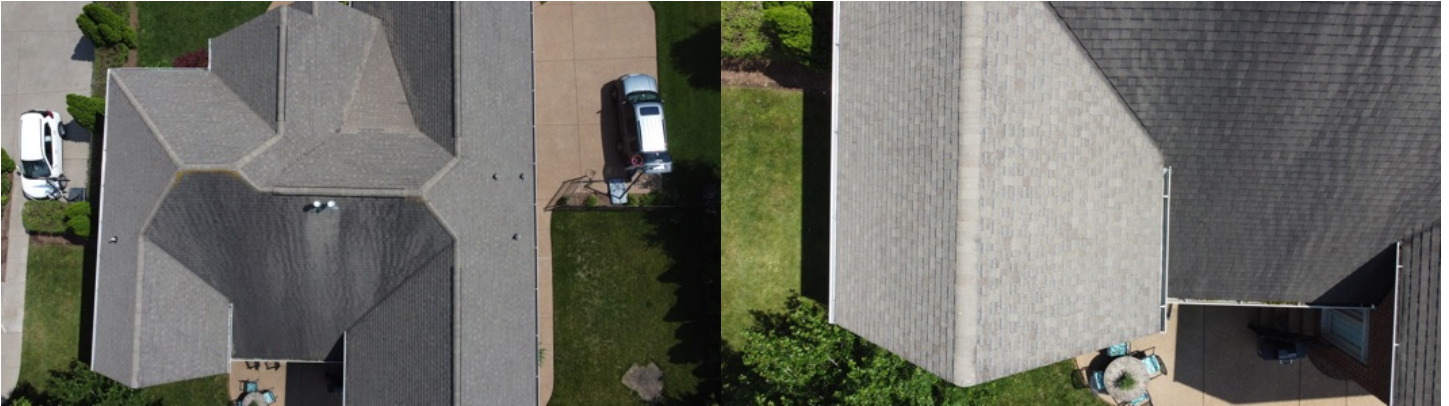
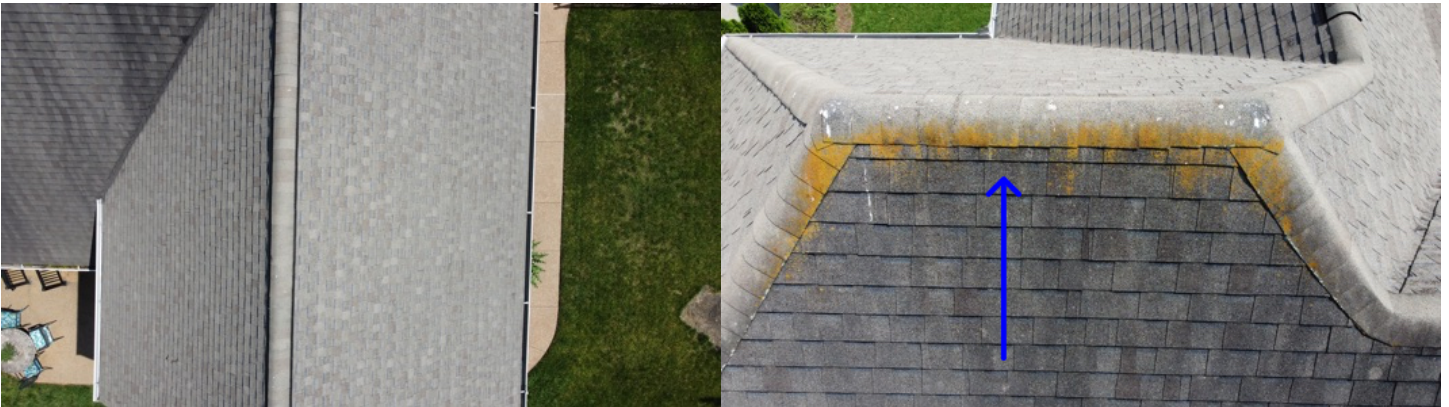
- Damage/deterioration was noted on the roofing shingles. Recommend having a roofer make further evaluation and repair/replace any needed shingles.
- A few shingles had been raised by the wind and need to be resecured.
- Moss was observed on the roofing material. Moss retains moisture and can cause damage. Recommend removing the moss to prolong the life of the shingles. Contact a qualified roofing professional for safe moss removal.

Lifted shingles-rear right gable

Lifted shingles-rear

Lifted shingles-left side

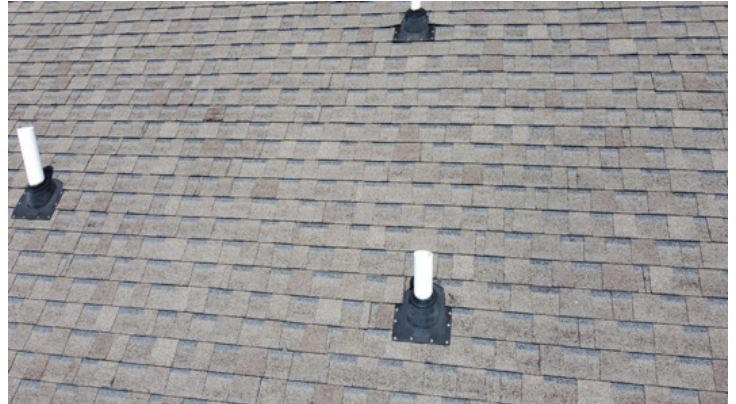
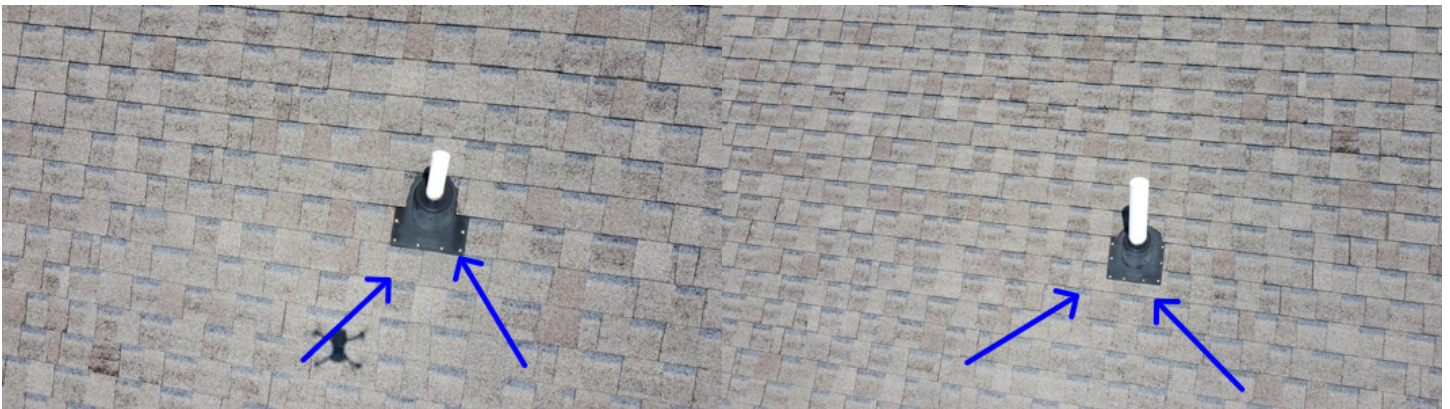
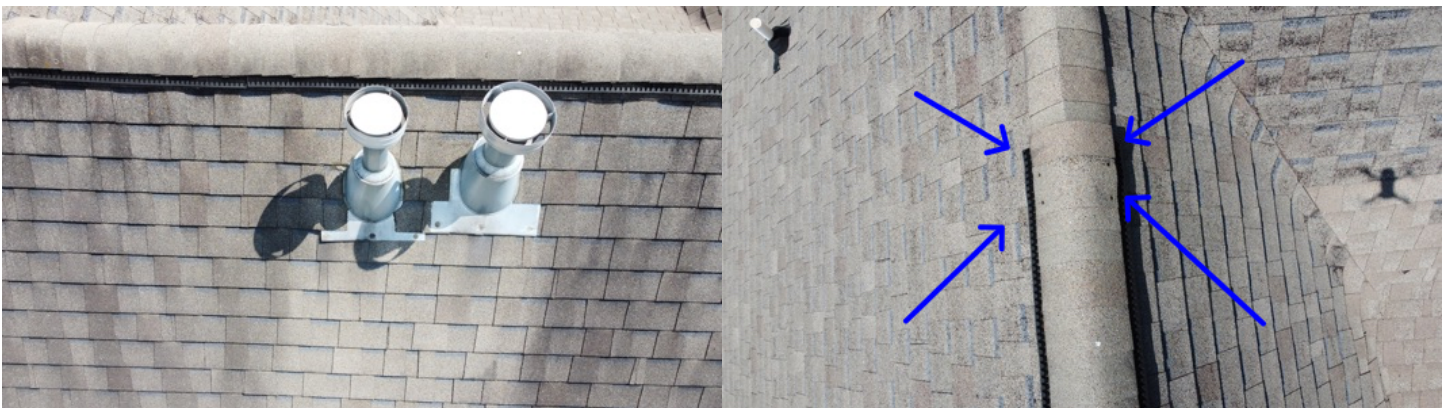
- No diverter flashing or kick-out flashing was found. This type of flashing keeps water from flowing down a wall where the roofline intersects it.

• Exposed fasteners were noted on the roof vent boots and ridge vents. All fasteners must be properly sealed to prevent rust and potential water entry.

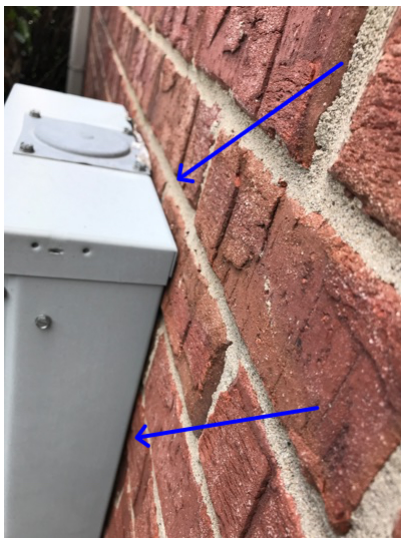
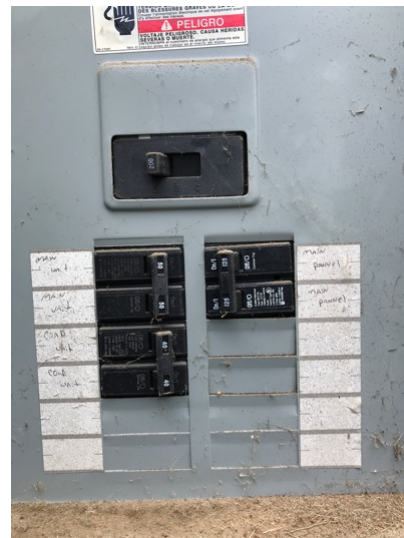
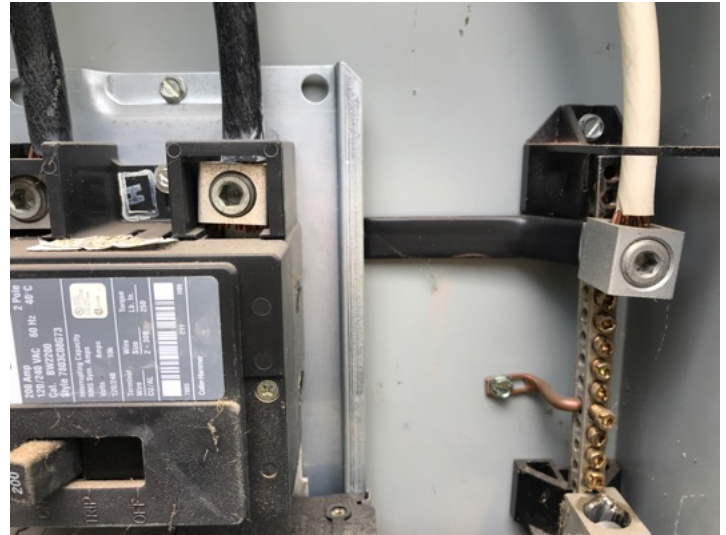
- Recommend sealing around the main electrical panel for optimal performance.
- Grounding system was present.
- Circuit and wire sizing was correct as visible.

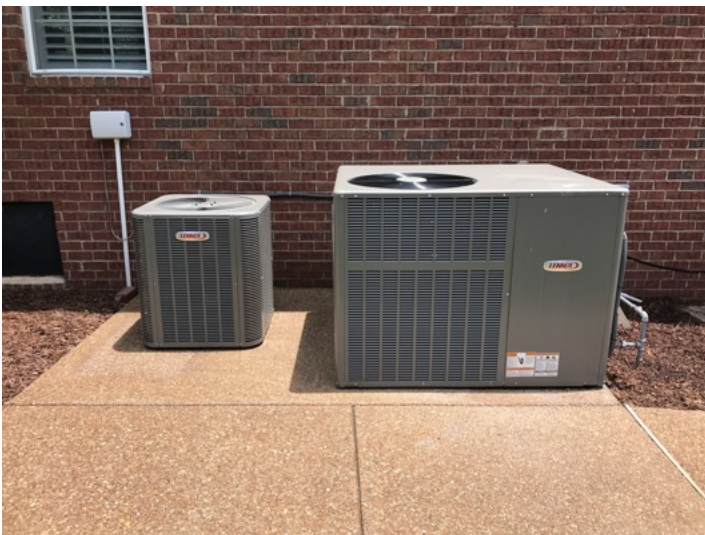
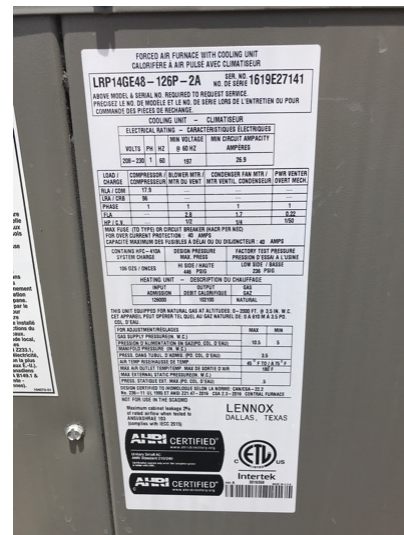
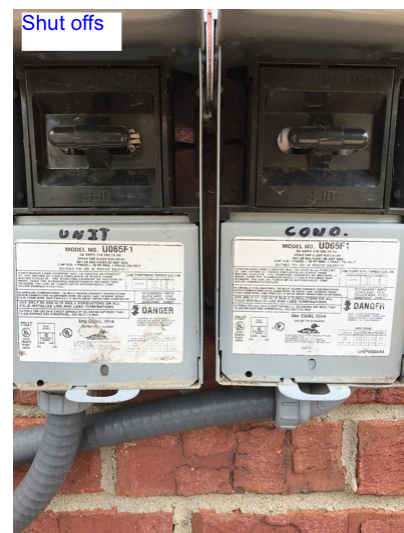
- Appeared operational. Units were operating at the time of the inspection. Manufactured by Lennox in 2019.
- The refrigerant line penetration had open gaps around it. Recommend sealing the open gaps to prevent moisture entry.

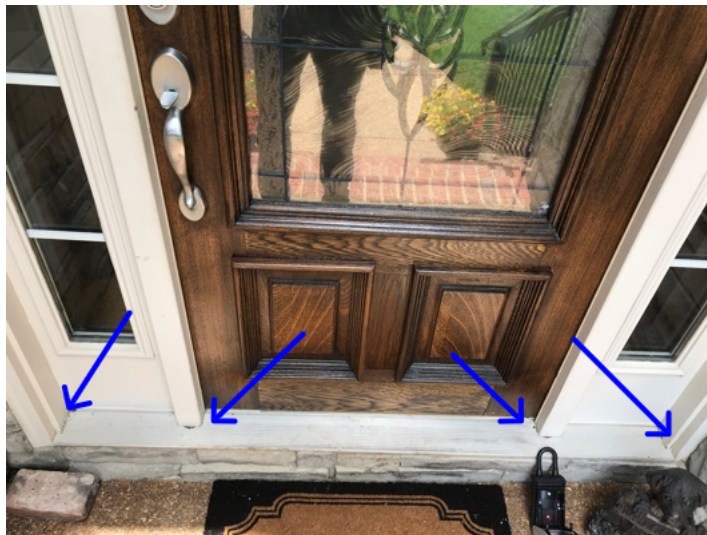
- The entrance door had a threshold that was not properly sealed at both base ends. Recommend caulking to prevent water entry.

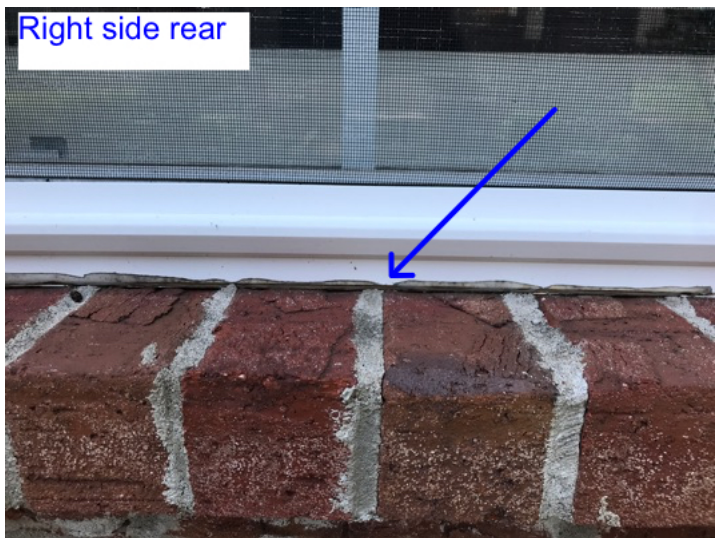
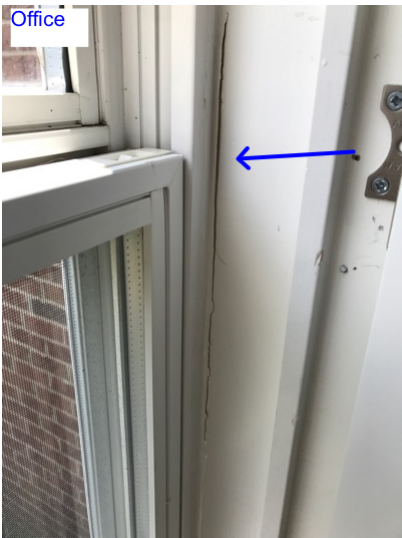
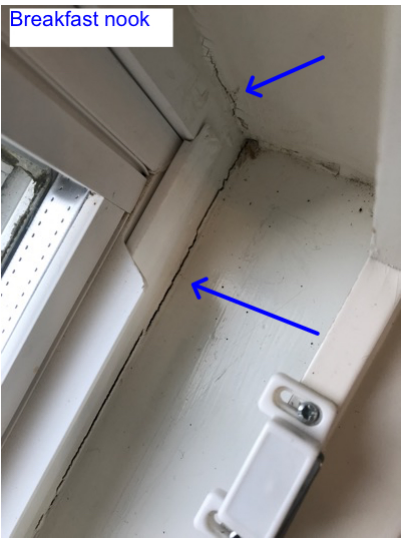
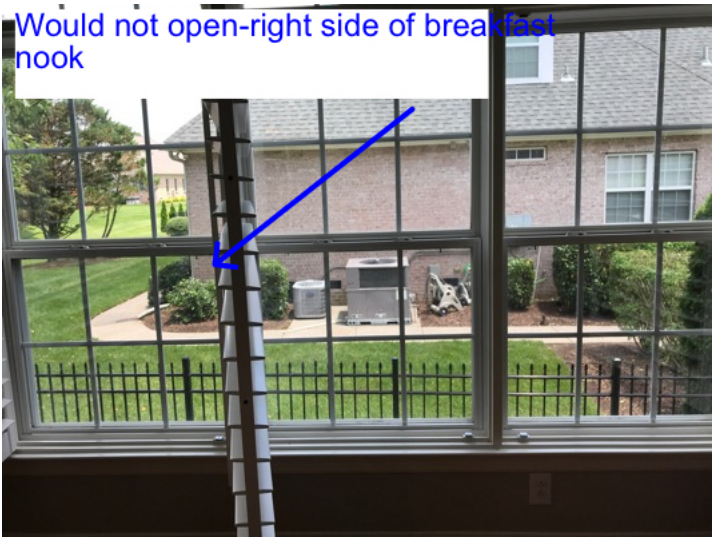
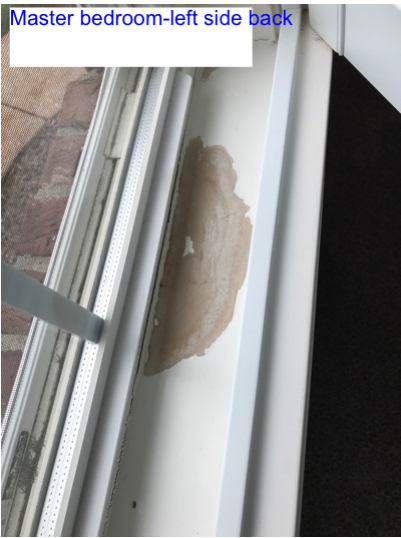
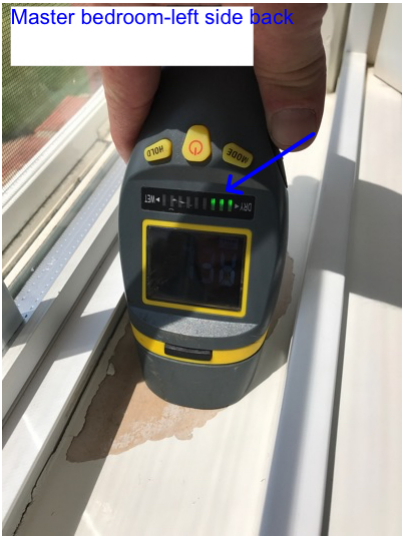
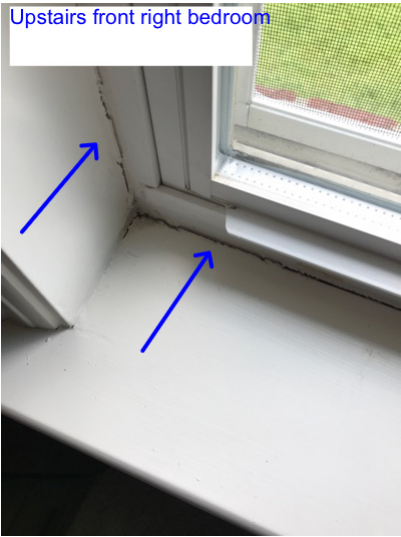
- Additional caulking was needed around the interior windows to prevent energy loss.
- The left window on the right side of the breakfast nook would not open. Adjustments are needed.
- Caulking was needed around the exterior windows to prevent moisture entry.
- Paint damage was noted in the left side back window in the master bedroom. The area showed signs of dampness when tested with a moisture meter. Recommend further evaluation and repair by a qualified professional for optimal performance.

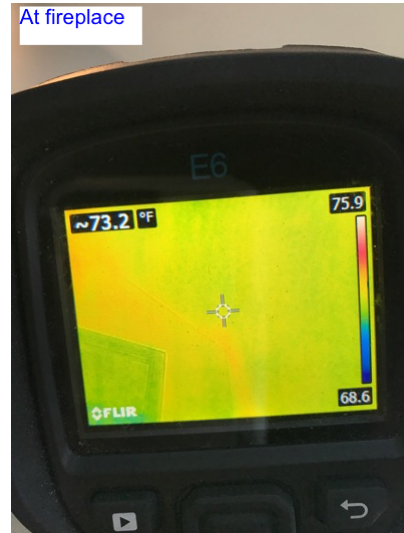
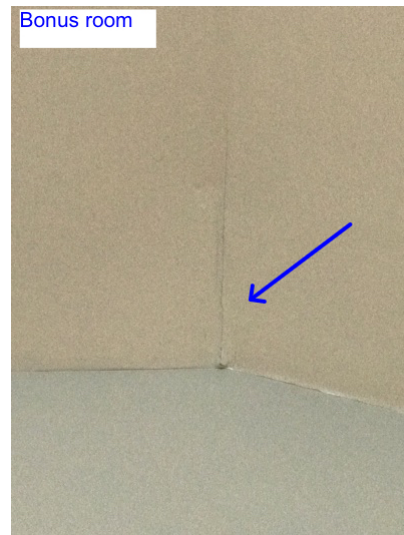
- Drywall
- Cracks were noted on the bonus room ceiling. Recommend repair by a drywall technician for optimal performance.
- Moisture stain was noted in the living room. Unable to determine if an active leak exists. The stain tested dry with a moisture meter. Make inquiry with the seller as to the history of leaks.

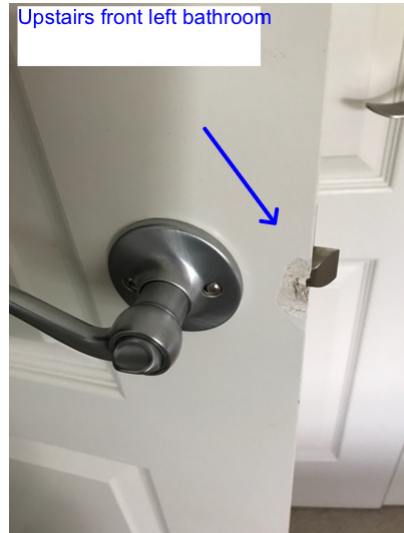
- Damage was noted at the latch of the upstairs front left bathroom. Repair as needed.
- The laundry room door didn't latch closed properly. Adjust the door/striker plate to allow the door to latch closed properly.
- A damaged ball closure mechanism was noted on the right closet door in the upstairs front right bedroom. Recommend repair for optimal performance.

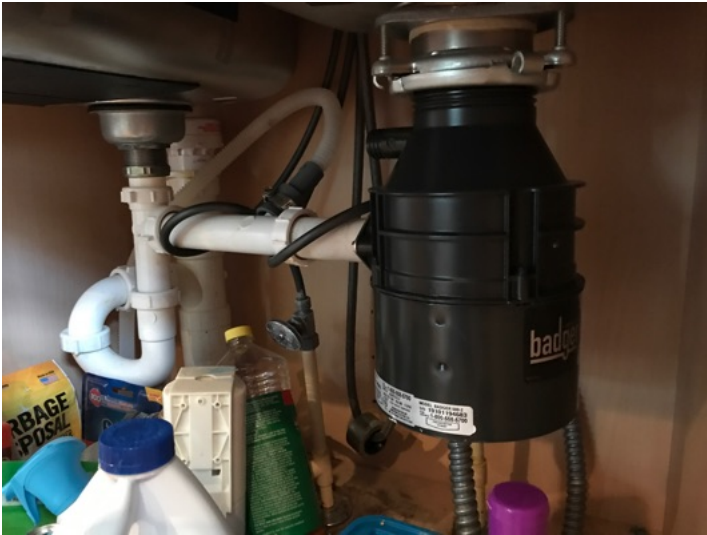
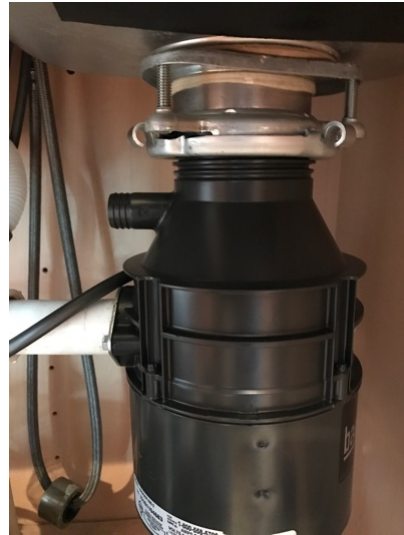
- Unit turned on but made loud noises. Repair is needed.

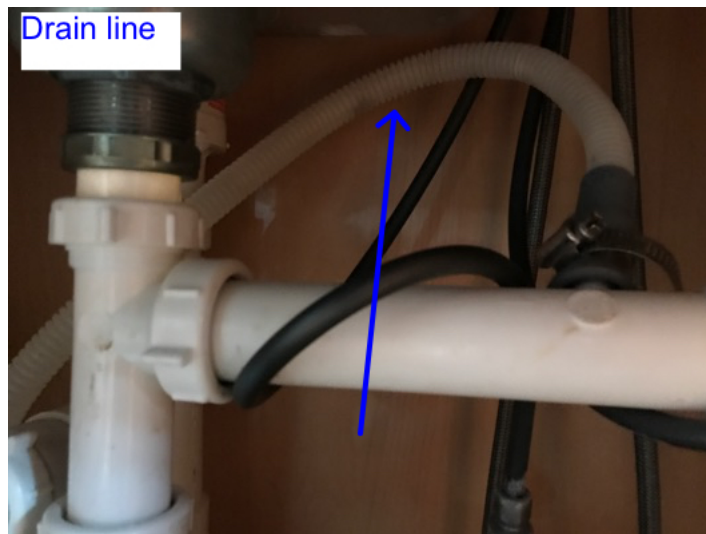
- An **air gap** device or high-loop was not present on the drain line. All dishwashers must have their drain line looped up above the flood rim of the sink to prevent water from backing up into the dishwasher.

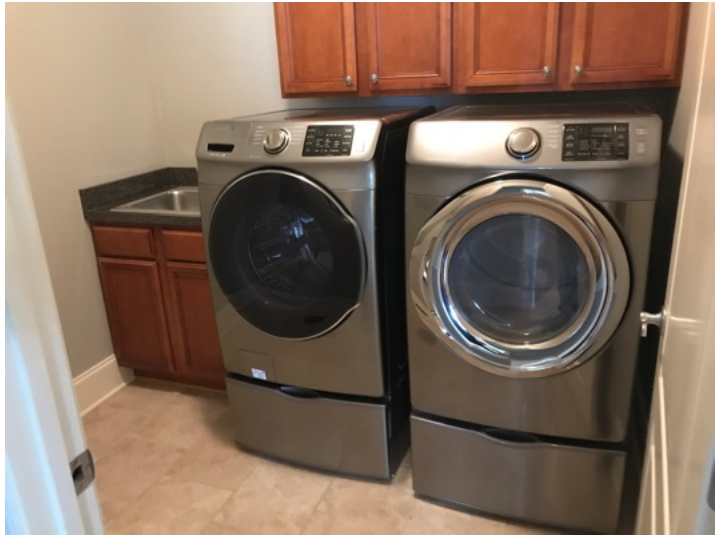
- Vent needed cleaning. Dryer vents must remain free of lint build up as this can be a fire hazard.

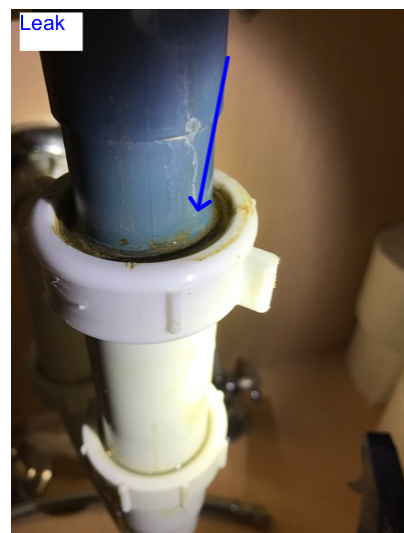
- Leak was noted under the sink at the drain line connection tail piece.

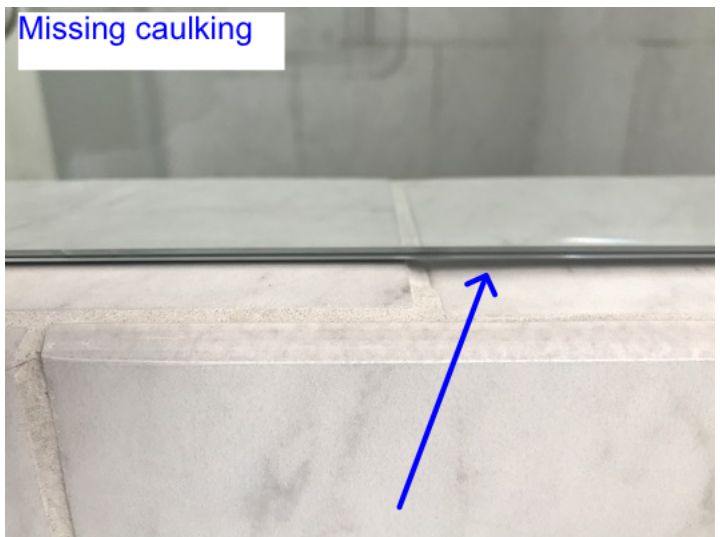
- Chipped glass was noted on the shower surround. Recommend replacing it for optimal safety.
- Missing caulking was noted around the glass shower surround. Recommend installing it for optimal moisture management.

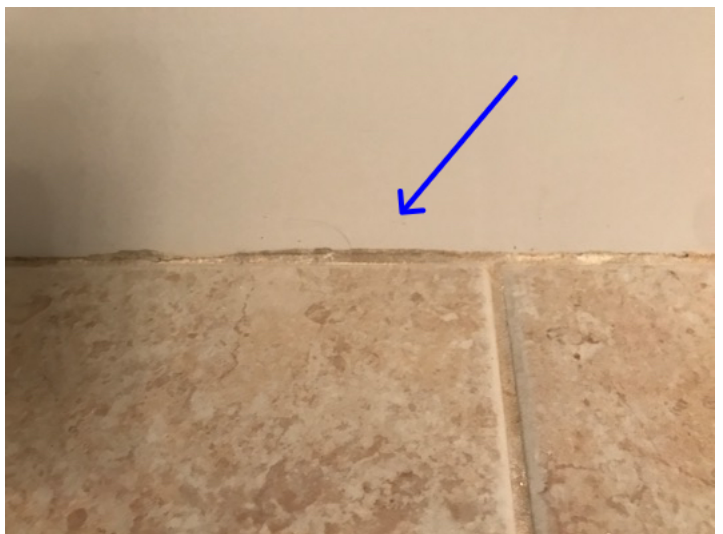
- Additional caulking was needed around the base of the bathroom tub. Recommend sealing the open gaps to prevent moisture entry.

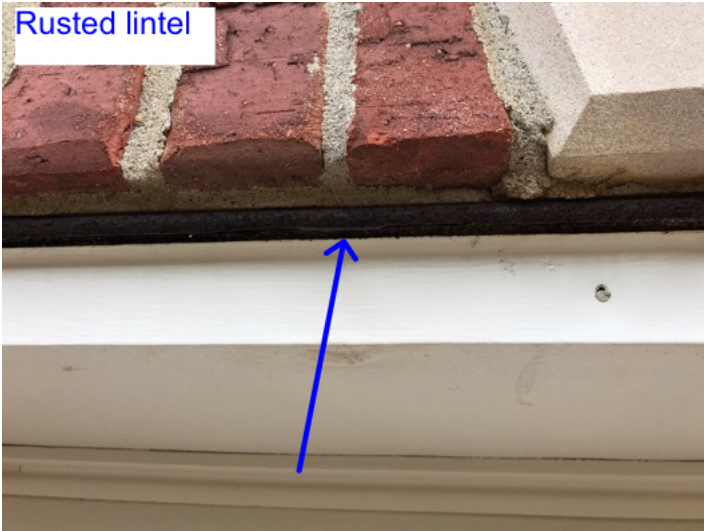
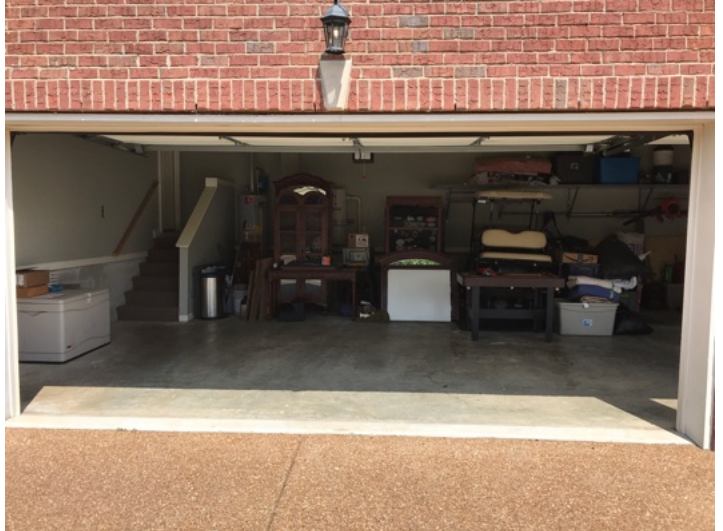
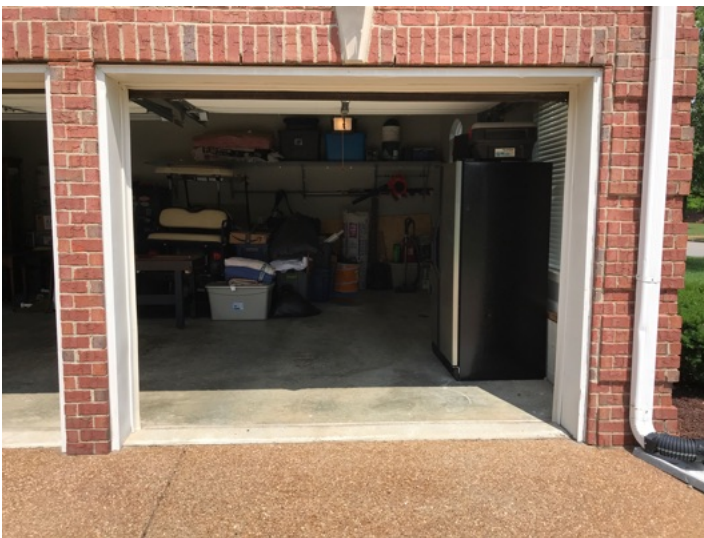
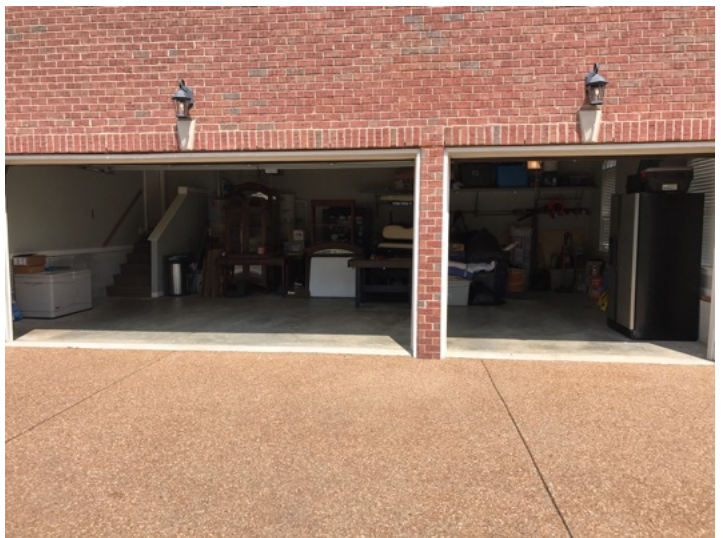
- Floor is not fully visible, due to stored items
- Rusted lintels were noted above the garages. Recommend painting them to prevent further rust from moisture.

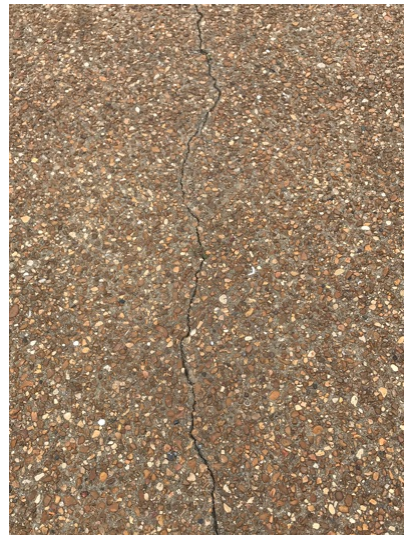
- Recommend repairing the cracks in the driveway with a proper crack sealer so that water will not enter the cracks.

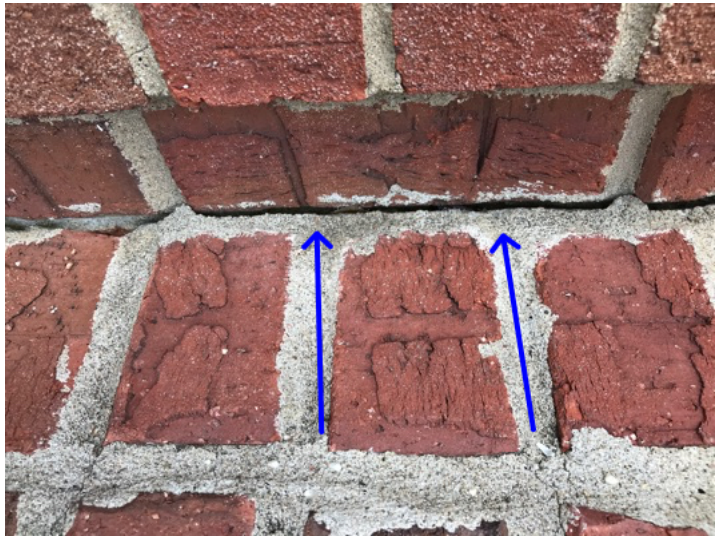
- Steps were settling around the front porch. Recommend sealing the open gaps to prevent moisture entry.
- Deteriorated brick mortar was noted around the front entry brick stairs. Recommend sealing the open cracks and filling in the mortar to prevent moisture entry.
