House On The Rock Inspections

Property Condition Report

123 Inspectors St, City, TN 23456
Inspection prepared for:
Real Estate Agent: -

Date of Inspection: 6/7/2021 Time: 12:00 PM
Age of Home: 2002 Size: 3615

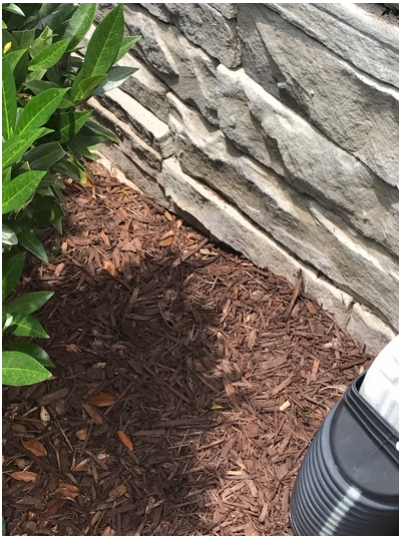
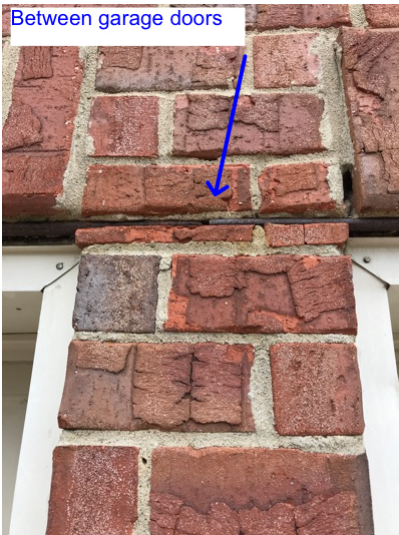
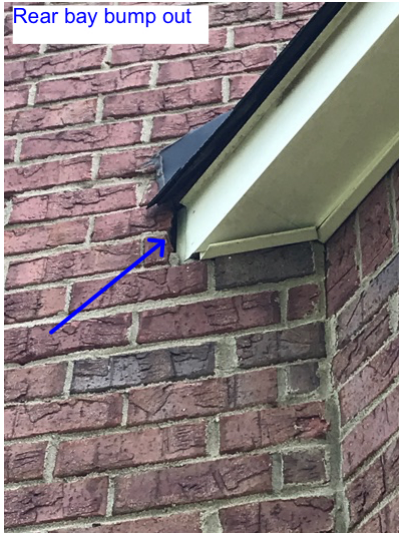
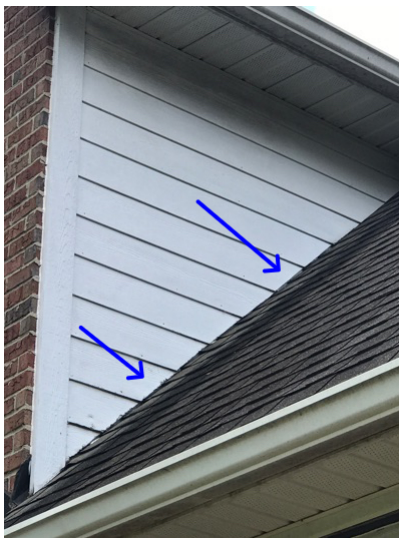
1. CLADDING CONDITION

- The stone siding was in contact with the ground. A minimum of a 4" clearance is necessary between the ground and the stone siding on the home. Recommend making the needed adjustments to allow for the proper clearance.
- Missing brick mortar was noted around areas of the house. Recommend sealing the open gaps to prevent moisture entry and further deterioration.
- The Hardie siding was in contact with the roofing shingles. A minimum of a 2" clearance is necessary between the ground/roof and the siding on the home. Recommend making the needed adjustments to allow for the proper clearance per the manufacturer's installation requirements.
- Missing vent baffles were noted on the left side of the house. Recommend repair to prevent pest and moisture intrusion.

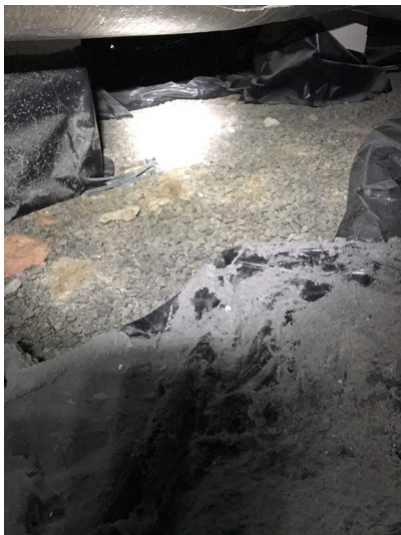
1. FOUNDATION CONDITIONS

- The moisture barrier in place had shifted. Recommend having the barrier adjusted for proper coverage.
- Lint was noted in the crawlspace under the dryer vent. It appeared that the dryer vent had been damaged and repaired. Recommend removing all excess lint for optimal performance.

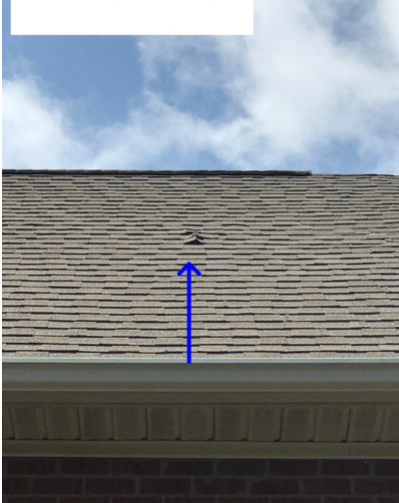
Lifted shingles-rear right gable

- Damage/deterioration was noted on the roofing shingles. Recommend having a roofer make further evaluation and repair/replace any needed shingles.
- A few shingles had been raised by the wind and need to be resecured.
- Moss was observed on the roofing material. Moss retains moisture and can cause damage. Recommend removing the moss to prolong the life of the shingles. Contact a qualified roofing professional for safe moss removal.

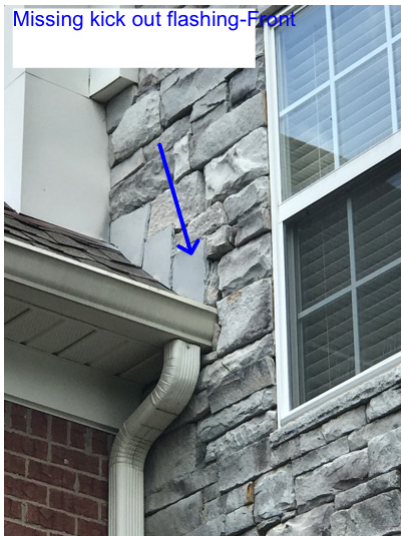
- No diverter flashing or kick-out flashing was found. This type of flashing keeps water from flowing down a wall where the roofline intersects it.

• Exposed fasteners were noted on the roof vent boots and ridge vents. All fasteners must be properly sealed to prevent rust and potential water entry.

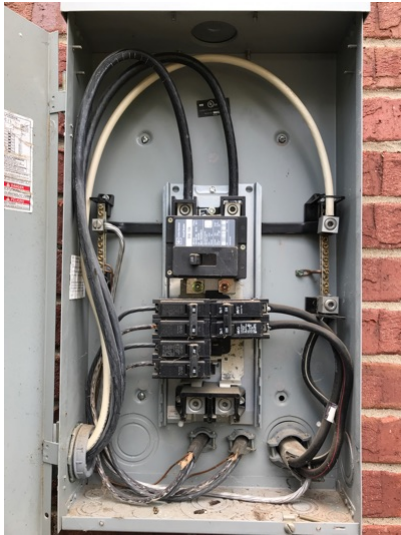
2. SERVICE PANEL CONDITION

- Recommend sealing around the main electrical panel for optimal performance.
- Grounding system was present.
- Circuit and wire sizing was correct as visible.

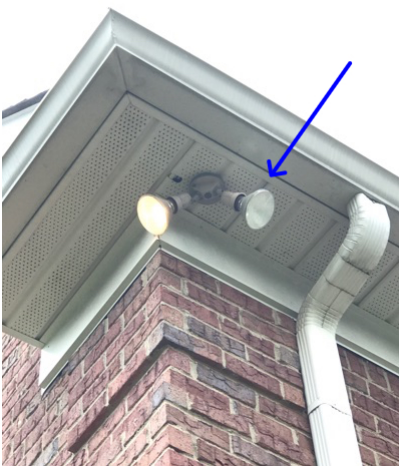
Front middle flood

- Lights were not operational in areas throughout the house, likely due to bad bulbs. Recommend replacing the bulbs.
- Open gaps were noted between the brick and the exterior light fixtures. Recommend caulking/sealing around all exterior outlets and fixtures for optimal safety as water/moisture can penetrate.

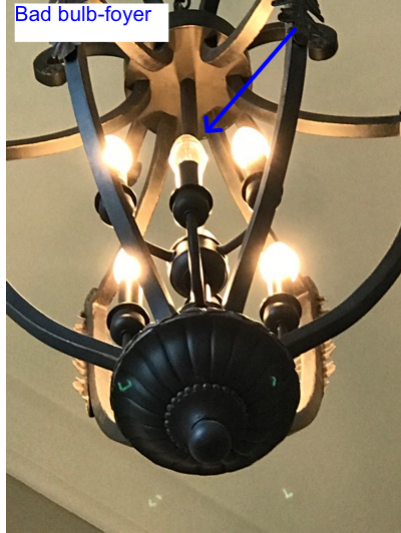
Bad bulb-foyer

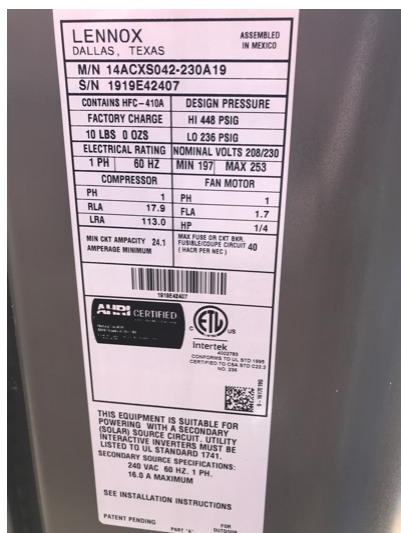
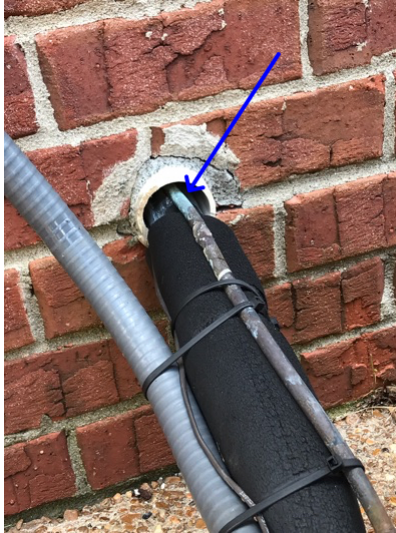
1. HVAC OVERALL CONDITION

- Appeared operational. Units were operating at the time of the inspection. Manufactured by Lennox in 2019.
- The refrigerant line penetration had open gaps around it. Recommend sealing the open gaps to prevent moisture entry.

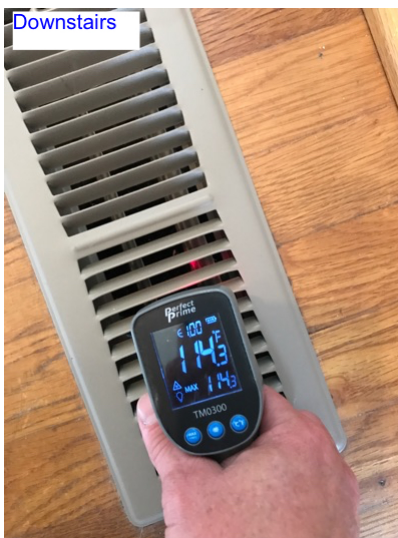
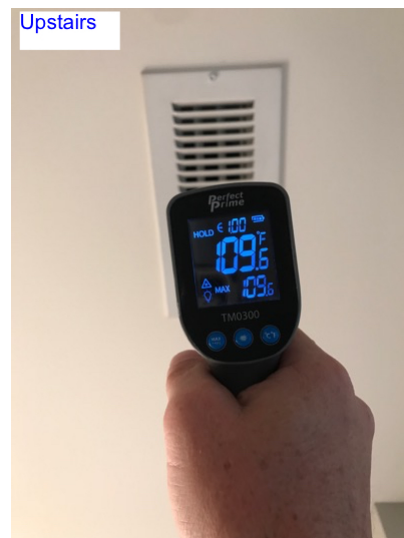
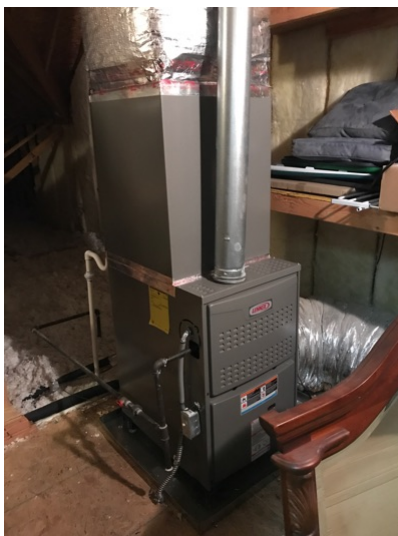
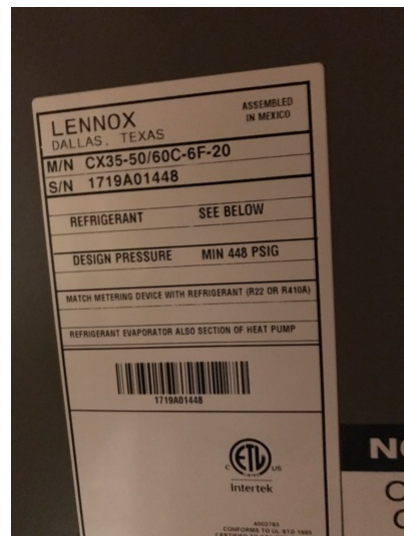
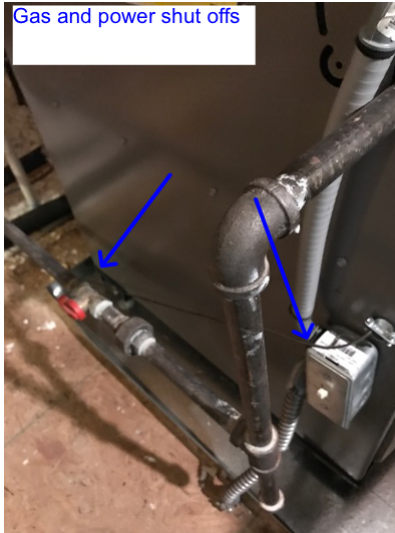
- Appeared operational. Units were providing heat at the time of the inspection.

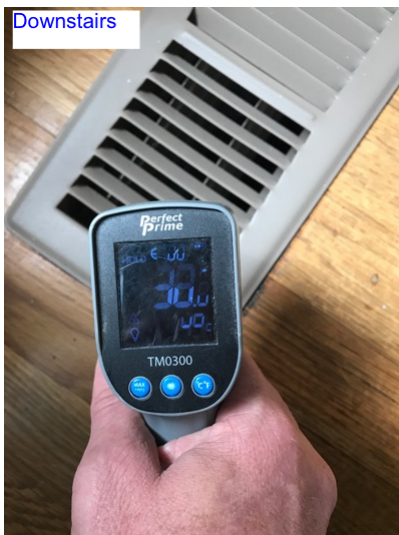
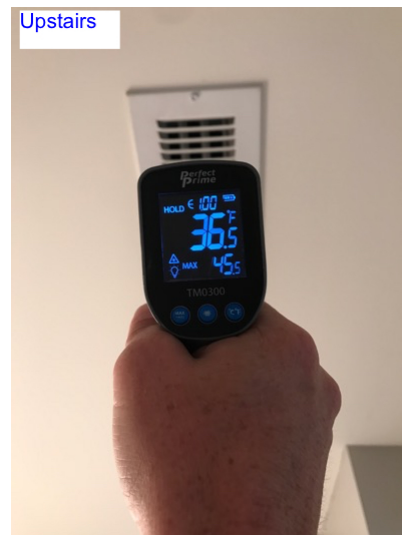
- The AC systems were cooling at the time of the inspection.

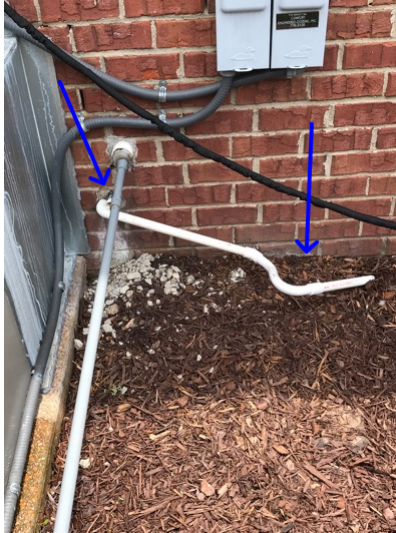
- Condensate line was installed.
- The end of the condensation line was draining by the foundation. It is advisable to extend the line so it is discharging further away from the foundation.

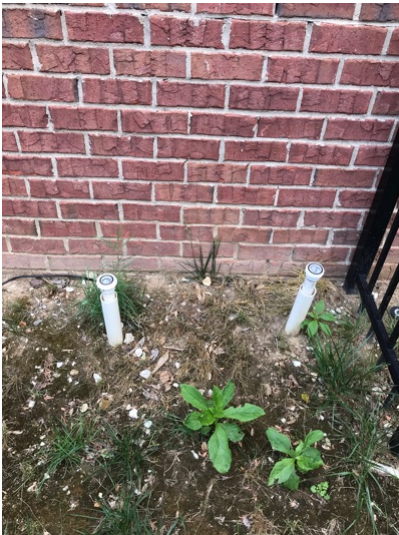
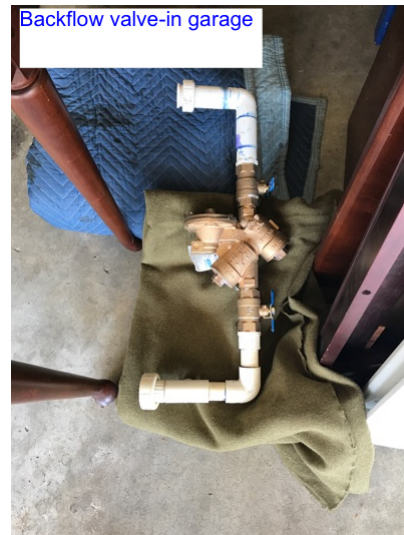
- Plumbing for a backflow device was installed. When installed the device must be protected from freezing as the valve will be damaged if it freezes. Many homeowners have them removed by their lawn irrigation contractor every year or install an insulated cover to protect them.

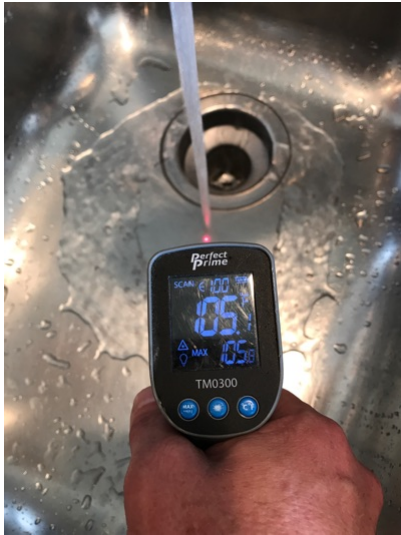
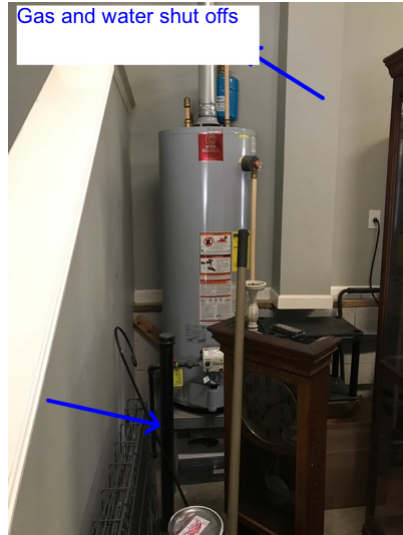
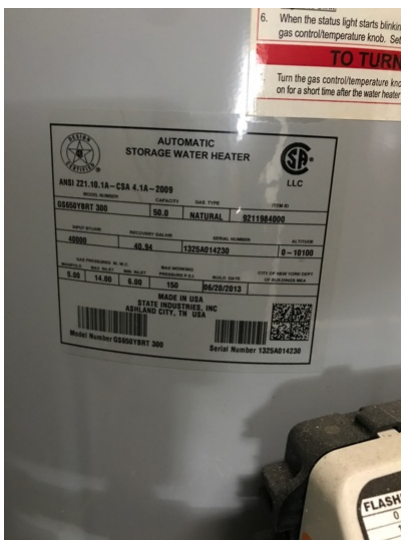
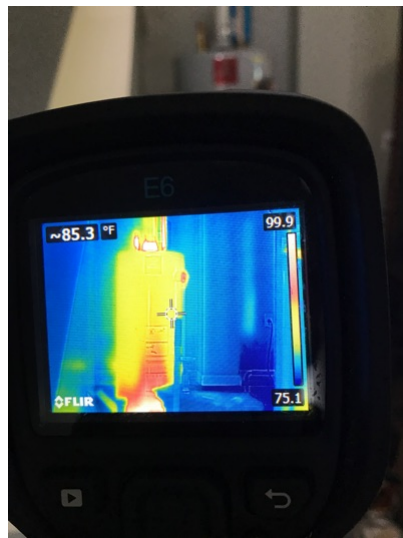
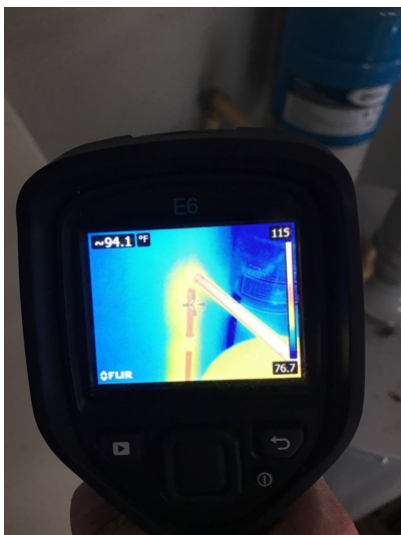
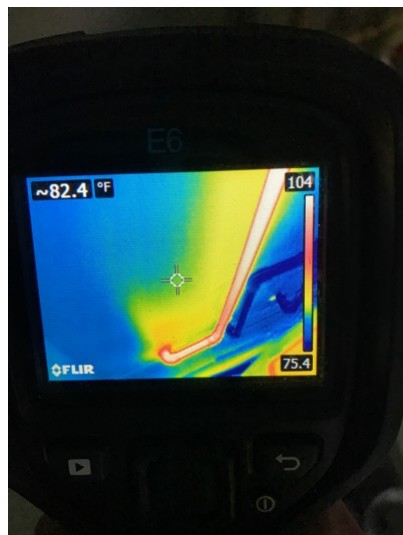
- Appeared serviceable. Manufactured by State in 2013. The water heater was functioning normally. However, it is advisable to have the water heater serviced due to age.

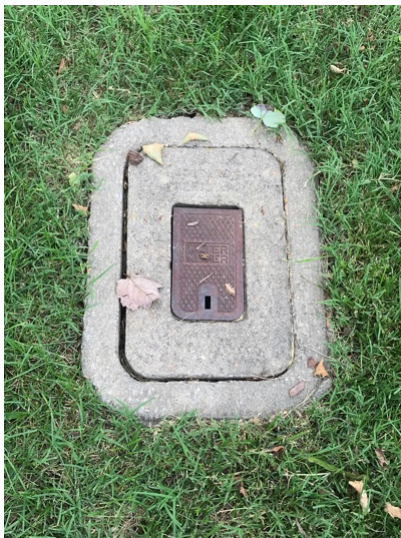
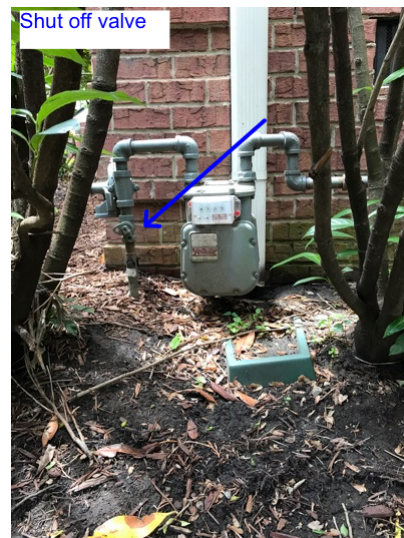
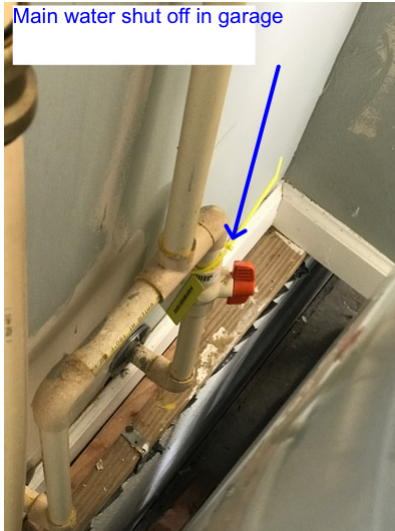
- The water shut off valve for the home was located near the water heater.
- See photo for location of main gas shut-off valve. The main gas shut off valve was located at the meter base. This is important to know in case of an emergency. The valve can be turned to the off position with an adjustable wrench by lining up the holes in the meter valve.

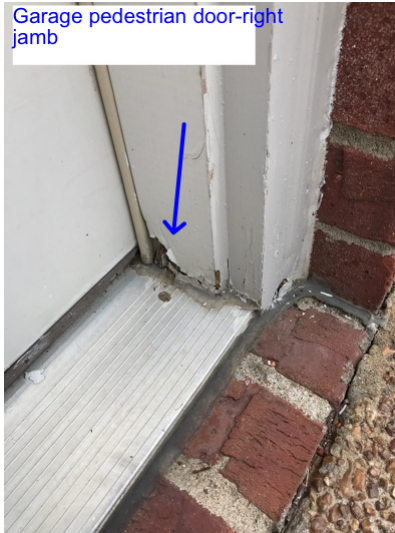
- Rot was noted at the lower parts of the door frame/jamb on the garage entrance. Replace all rotted wood.

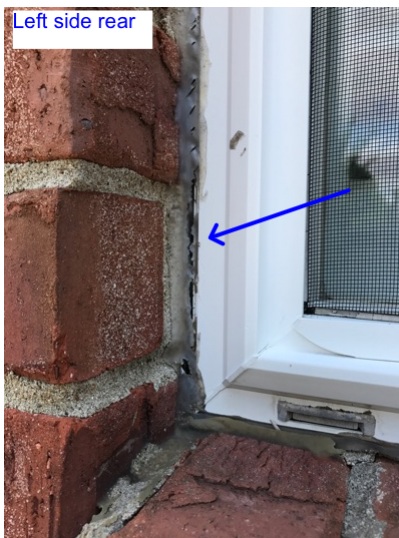
- Additional caulking was needed around the interior windows to prevent energy loss.
- The left window on the right side of the breakfast nook would not open. Adjustments are needed.
- Caulking was needed around the exterior windows to prevent moisture entry.
- Paint damage was noted in the left side back window in the master bedroom. The area showed signs of dampness when tested with a moisture meter. Recommend further evaluation and repair by a qualified professional for optimal performance.

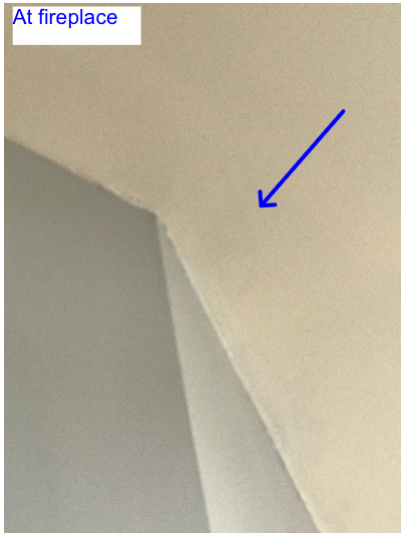
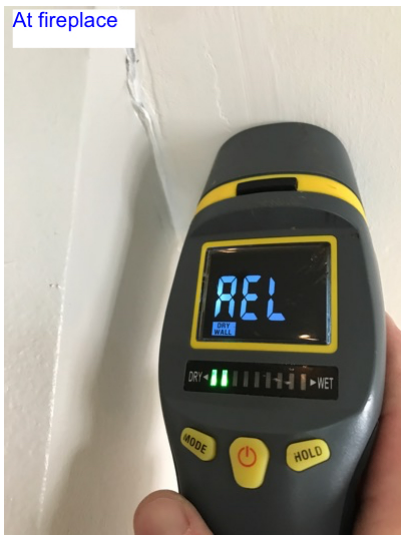
- Drywall
- Cracks were noted on the bonus room ceiling. Recommend repair by a drywall technician for optimal performance.
- Moisture stain was noted in the living room. Unable to determine if an active leak exists. The stain tested dry with a moisture meter. Make inquiry with the seller as to the history of leaks.

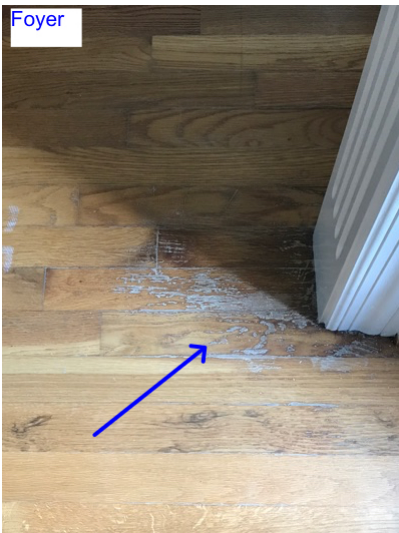
Foyer

- The carpet was stained. Clean as needed.
- Worn flooring was noted throughout the downstairs. Recommend refinishing the marred wood floor.
- Moisture damage was noted in the master bedroom along the left wall. Unable to determine if an active leak exists. The area tested dry with a moisture meter. Make inquiry with the seller as to the history of leaks.

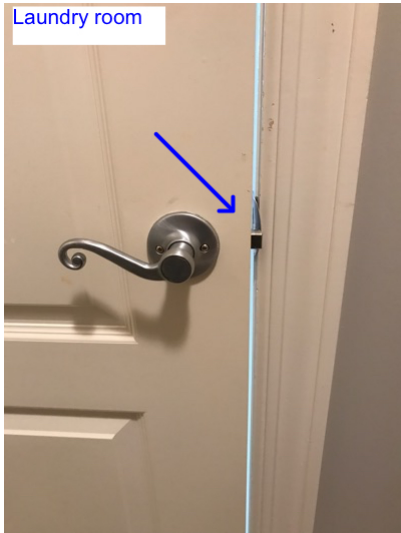
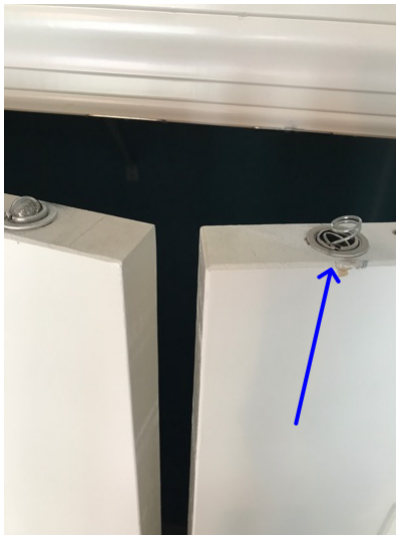
- Damage was noted at the latch of the upstairs front left bathroom. Repair as needed.
- The laundry room door didn't latch closed properly. Adjust the door/striker plate to allow the door to latch closed properly.
- A damaged ball closure mechanism was noted on the right closet door in the upstairs front right bedroom. Recommend repair for optimal performance.

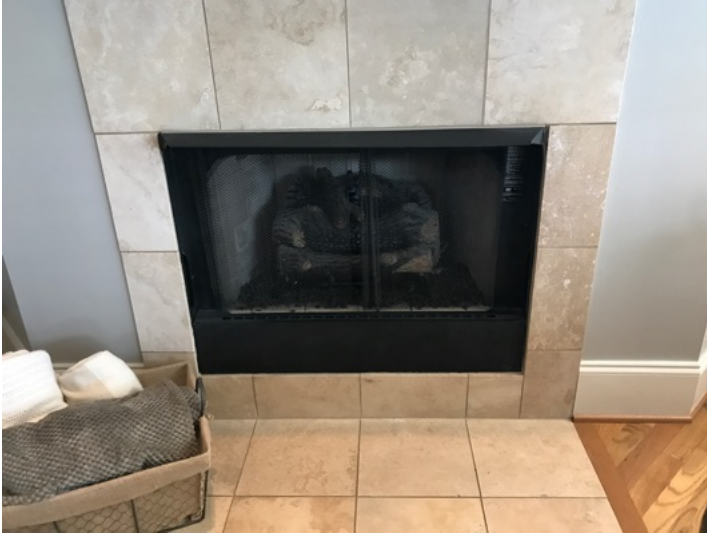
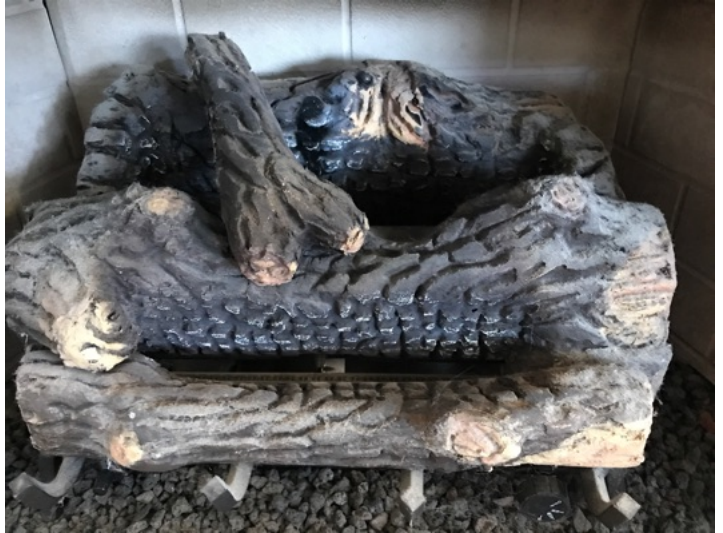
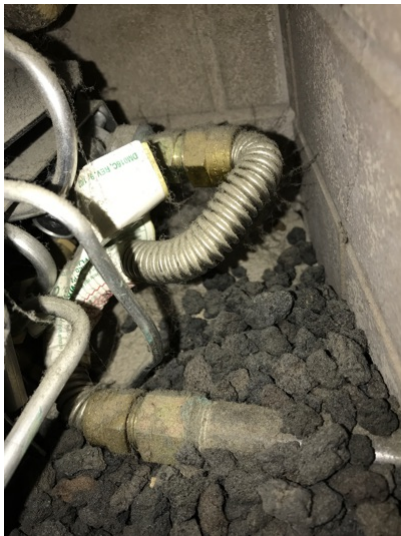
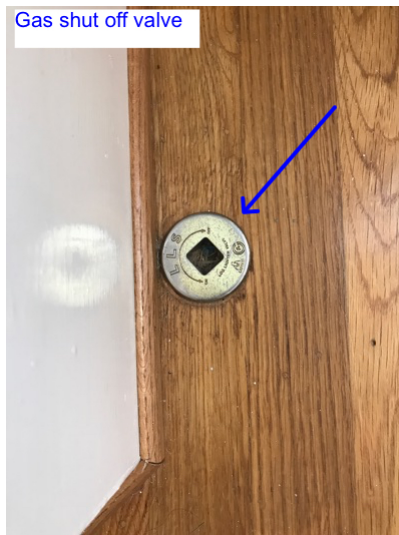
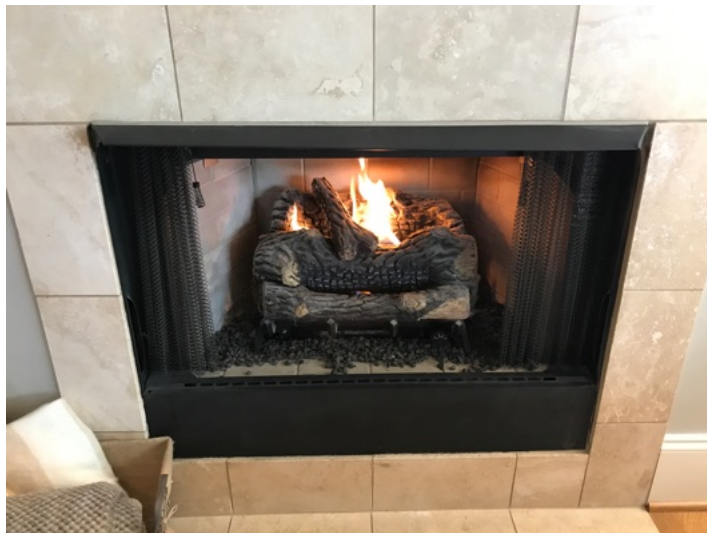
8. FIREPLACE CONDITION

Materials: Ventless gas logs were installed. This is a space heater in the shape of logs. Read the manufacturers instructions about proper operation. **DO NOT BURN ANYTHING OTHER THAN THESE GAS LOGS IN THE FIREPLACE!** Read the directions before use. • Living room.

- Appeared serviceable.

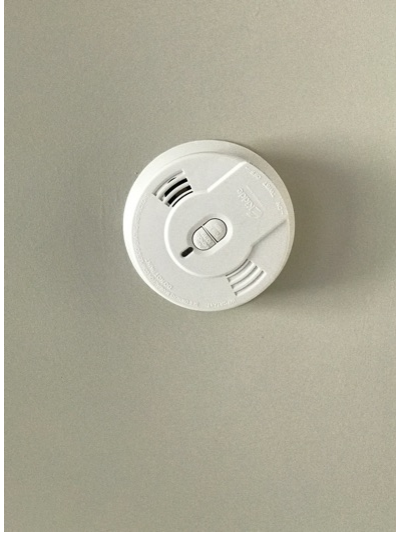
- Replace all smoke detectors after 7 years, or when a home is purchased. The American Society of Home Inspectors recommends photo electric type smoke detectors.
- Recommend the installation of a carbon monoxide alarm inside any home that has any fossil fuel appliances or systems in the home. They should be replaced every 5 years or as directed by the manufacturer.

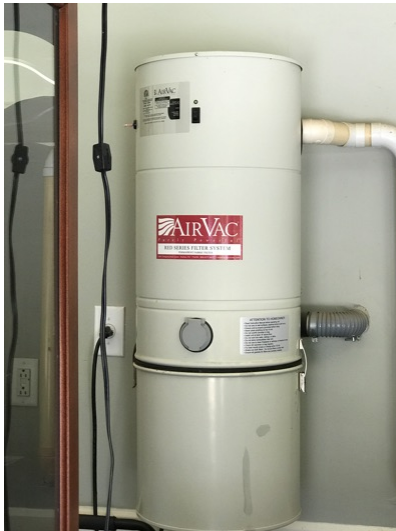
11. CENTRAL VAC

- Unit turn on but the system was not tested.

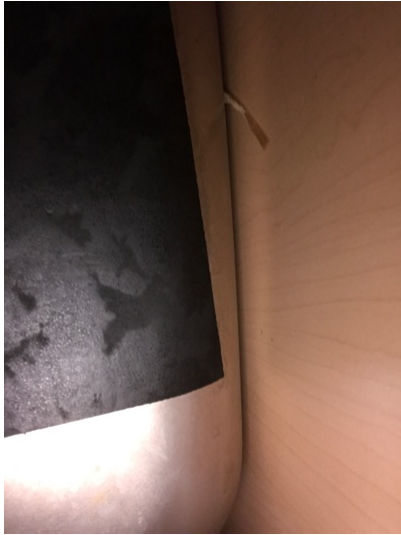
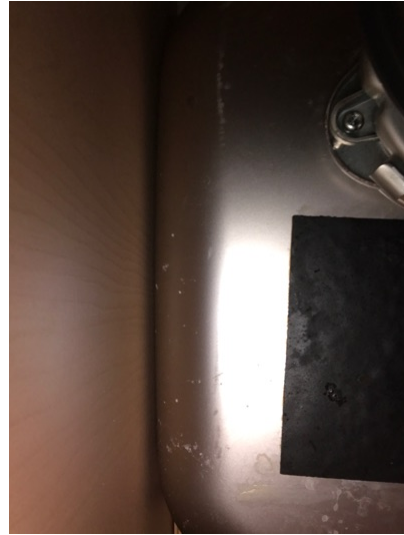
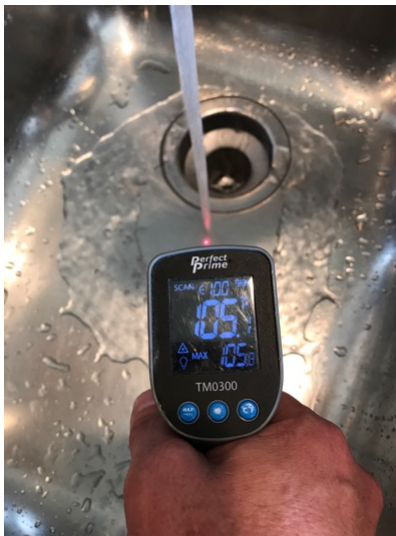
- Appeared serviceable.
- Faucet was serviceable.

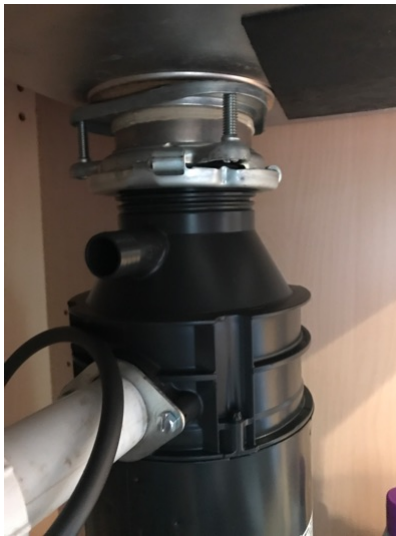
2. GARBAGE DISPOSAL

- Unit turned on but made loud noises. Repair is needed.

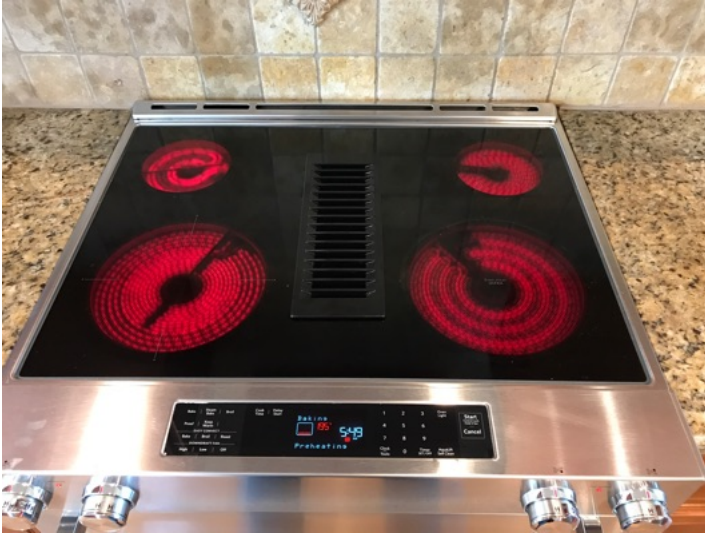
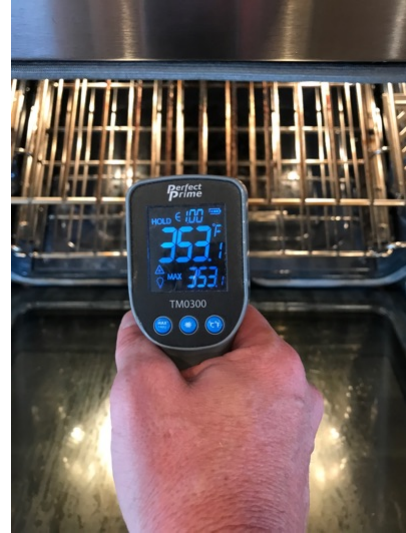
4. OVEN, STOVE, COOKTOP CONDITION

- Appeared serviceable.

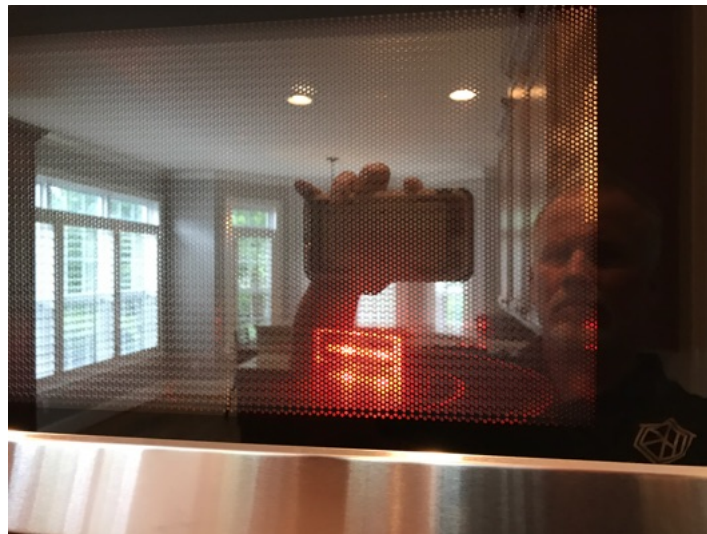
5. VENT FAN AND MICROWAVE CONDITION

- Fan/Hood was operational.
- Microwave appeared serviceable.

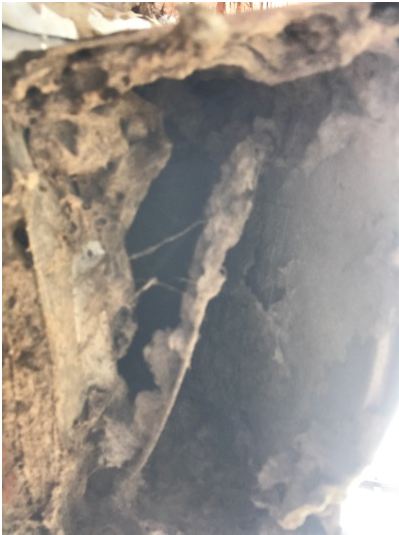
- Vent needed cleaning. Dryer vents must remain free of lint build up as this can be a fire hazard.

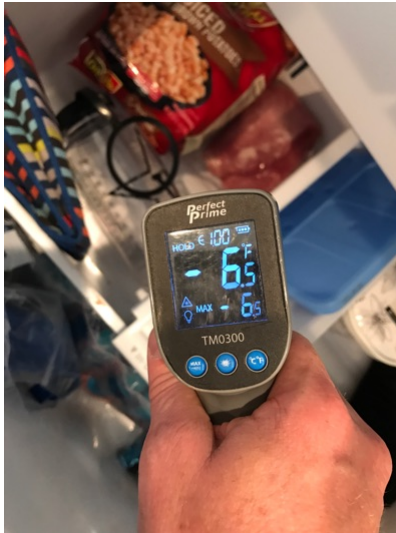
- Appeared serviceable at the time of inspection.

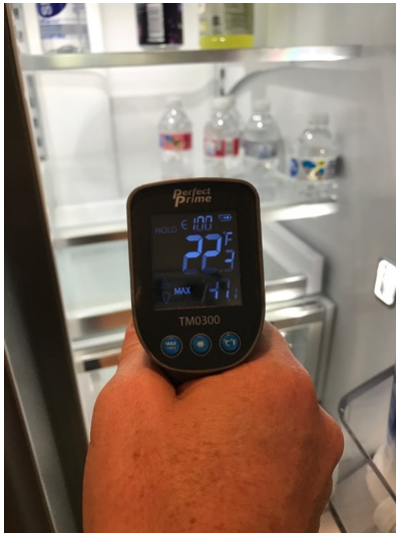
2. FRIDGE

- Appeared serviceable at the time of inspection.

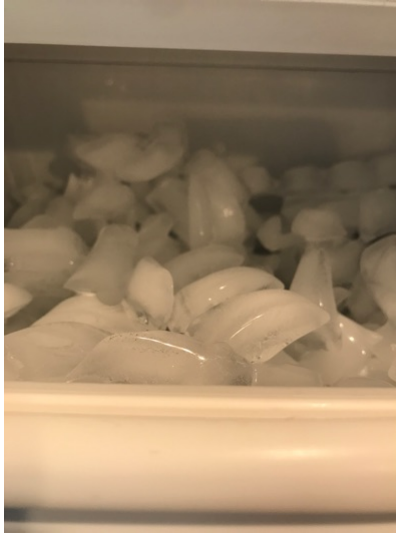
3. ICE MAKER

- Appeared serviceable at the time of inspection.

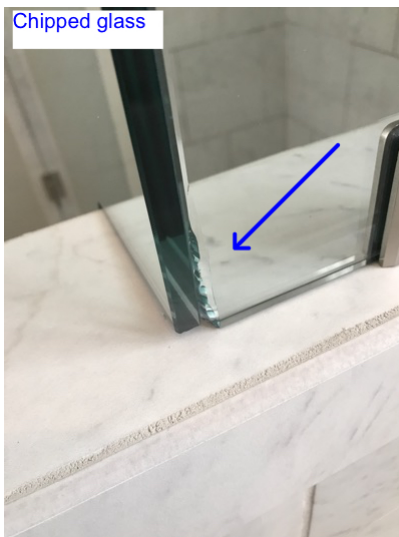
5. SHOWER

- Chipped glass was noted on the shower surround. Recommend replacing it for optimal safety.
- Missing caulking was noted around the glass shower surround. Recommend installing it for optimal moisture management.

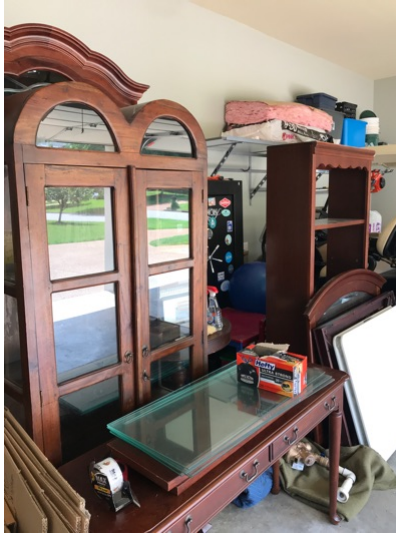
- Stored items restrict the full viewing of the garage area.

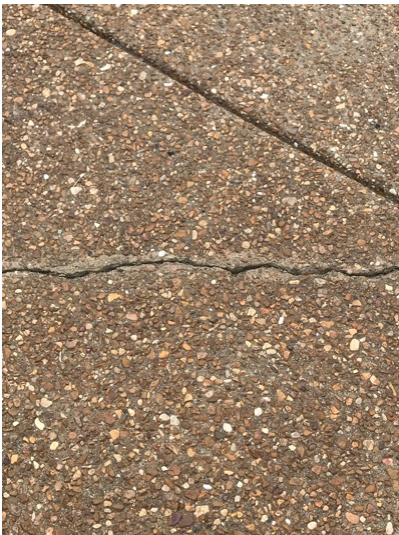
1. DRIVEWAY AND WALKWAY CONDITIONS

- Recommend repairing the cracks in the driveway with a proper crack sealer so that water will not enter the cracks.

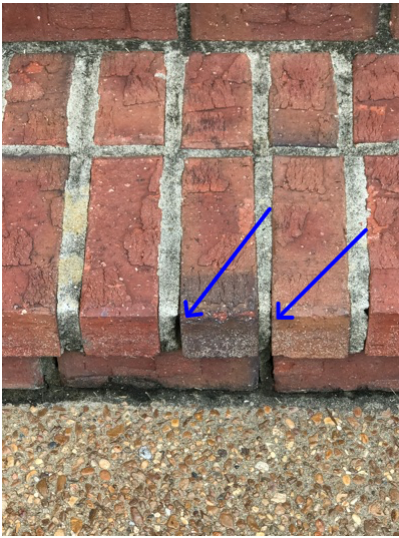
4. STEPS, STOOP AND STAIRS CONDITION

- Steps were settling around the front porch. Recommend sealing the open gaps to prevent moisture entry.
- Deteriorated brick mortar was noted around the front entry brick stairs. Recommend sealing the open cracks and filling in the mortar to prevent moisture entry.

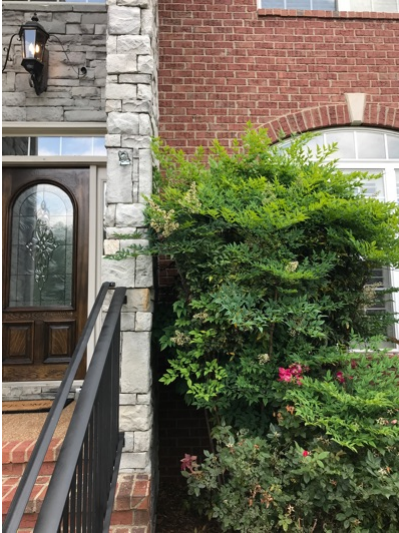
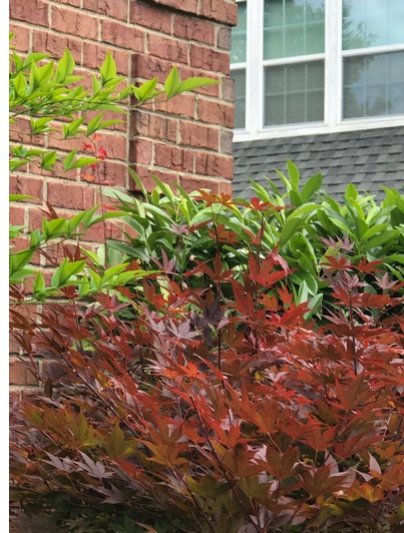
- The over grown plants needed to be trimmed back away from the home.
